Peatland mapping for Bengkalis Island, Riau, using limited LiDAR data and peat thickness field measurements

Submission by Deltares and ITB (Team Deltares)
to
Indonesian Peat Prize

Indonesian Peat Prize - Solution Development Phase

Final Report, June 2017

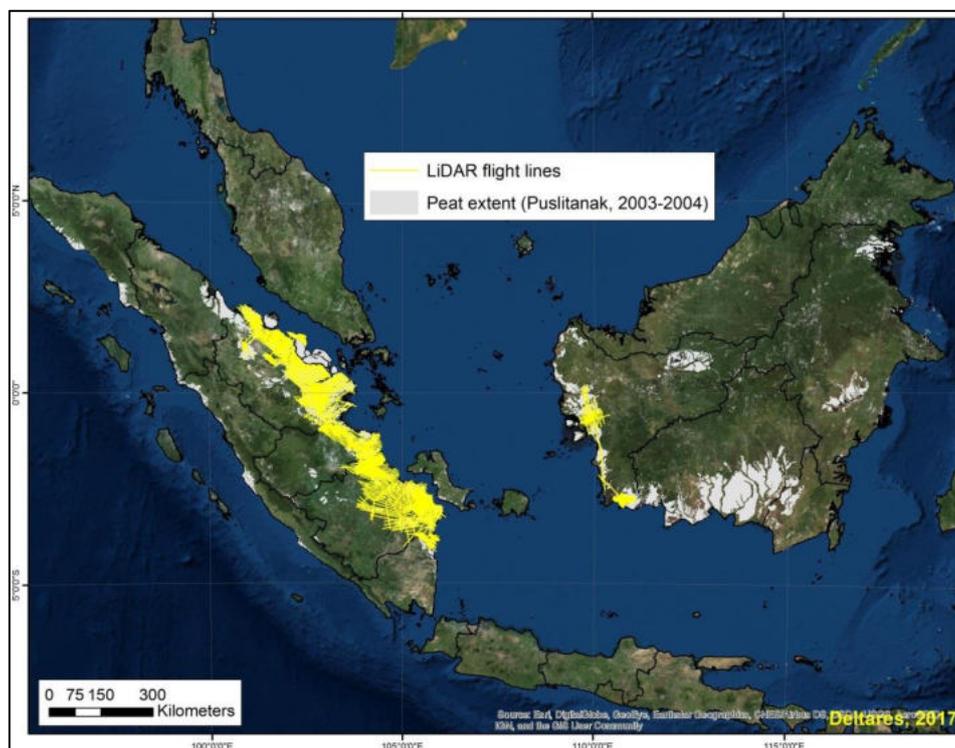
Figure 1 LiDAR flight line coverage over East Sumatra and West Kalimantan lowland acquired from April-May 2015 and October 2016 – March 2017.

LiDAR data has in 2015, 2016 and 2017 been collected over most of East Sumatra lowland and parts of West Kalimantan lowland (Figure 1), following the 'strip' method described in this report, mostly funded by APP (over its *Acacia* plantations and surrounding landscapes) and by UKCCU (over much of South Sumatra) with other organizations funding smaller areas of specific interest. First data over these areas was collected in April-May 2015¹, and a second round of data collection was done in October 2016 - March 2017. By mid-2017 this has resulted in coverage of 1.8 Mha of LiDAR data over a total of 26,300 km of flight lines. Most of this coverage is over lowland peatland.

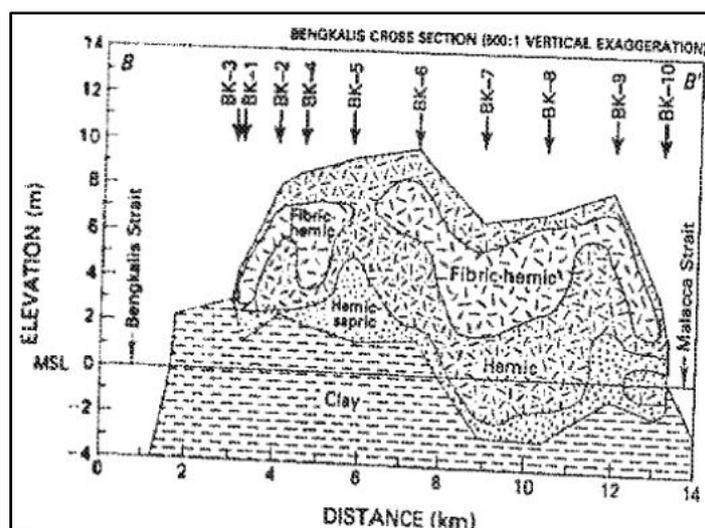
Figure 2 Cross section through Bengkalis Island showing extremely steep peat surface slopes (Supardi *et al.*, 1993). This cross section is to the West of the IPP study area.

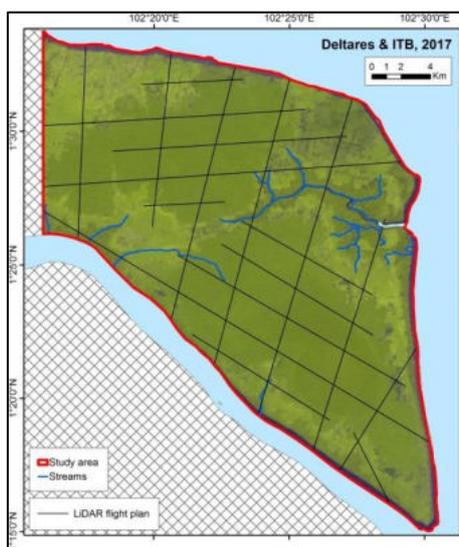
Figure 4 LiDAR flight plan over IPP study area as designed using existing peat extent maps, historical Landsat imagery (using vegetation patterns indicating presence of peat) and location of rivers and coast. In the background the RGB composite Landsat-1 image of 5 October 1972 (spectral bands 6-7-5) used. LiDAR flight line spacing is mostly at 2.5 km in this study.

To minimize cost and effort peat surveys in the field were optimized by conducting them [a] along transects perpendicular to coast and streams and going up the peat slopes (Figure 4), [b] starting transects at the expected peat extent boundary mapped visually from satellite data (Figure 21) and [c] ending surveys where PT was found to exceed 7 m (Figure 5). Measurement quality was assured by having the peat/mineral interface in augers photographed at all locations (time and location verified) and having multiple replicates for averaging and error rejection. A total of 274 average measurements were collected of which 219 had peat over 0.5 m in depth. Two-thirds of these measurements (n=146) were used for PT map creation, and one-third (n=73) for map validation. The field survey report and SOP are presented in Annex 1 and 2.

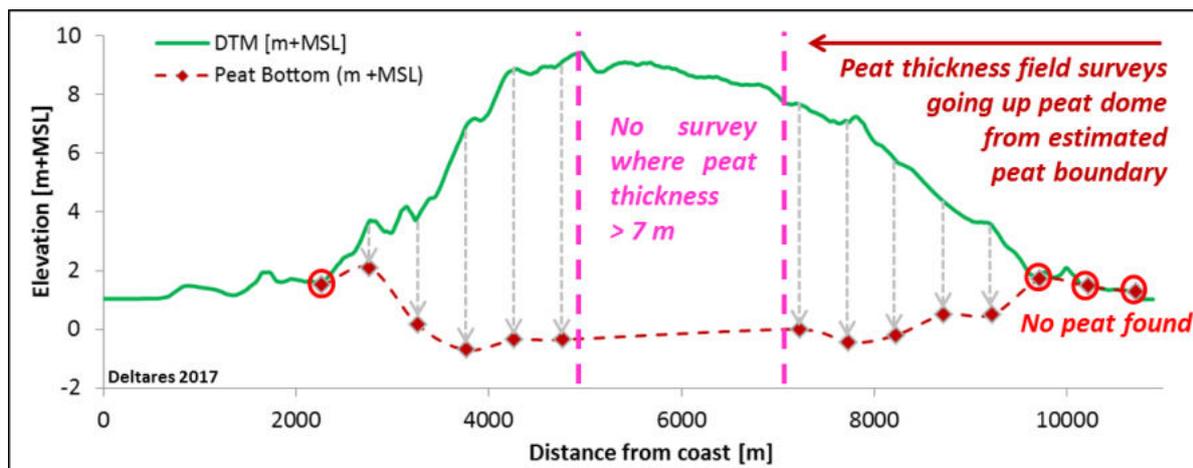
Figure 5 Schematic set-up of an effective and cost-efficient peat thickness survey. Surveys are planned perpendicular to coastlines and river as much as possible, which often matched the steepest slope of the peat dome. To reduce the number of sampling points in areas without peat, surveys start at a ‘likely peat boundary’ that is identified from satellite images. To reduce the number of measurements in areas where very deep peat is known to be present without further survey, surveys along transects end when a certain peat thickness limit is reached (in this case 7 m as these peat domes are small and steep, but sometimes a 5 m limit can be applied). By planning surveys in this manner, it is estimated that the number of survey locations can be reduced by over 50 % in many areas.

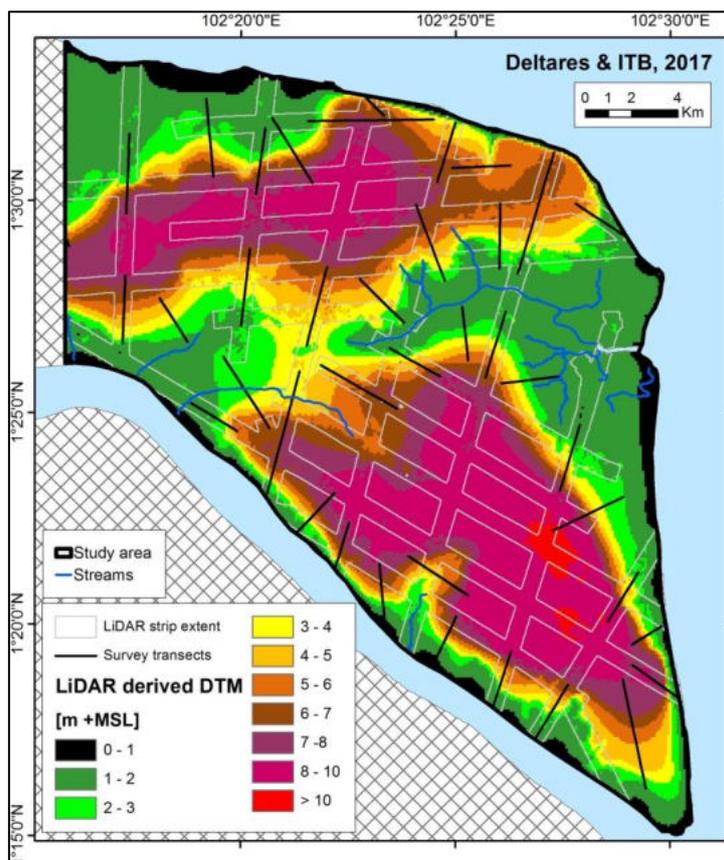
Figure 6 Peat thickness survey design along 44 transects, starting at areas where no peat was expected going perpendicular up the dome. In the background DTM generated from the LiDAR strip data (Figure 8).

Survey transects were designed to cross peat domes at perpendicular angles to extract the maximum of information from a minimum of data points. Transects started where no peat was expected to be found and along easy access points such as roads or canals, and extended up the domes to where peat was expected to be deep according to the DTM (Figure 5). Going up the dome, measurements were taken at 500 m intervals and were ended as soon as peat deeper than 7 m was found, to avoid spending much effort surveying large areas of very deep peat. In Figure 6 the survey design is presented.

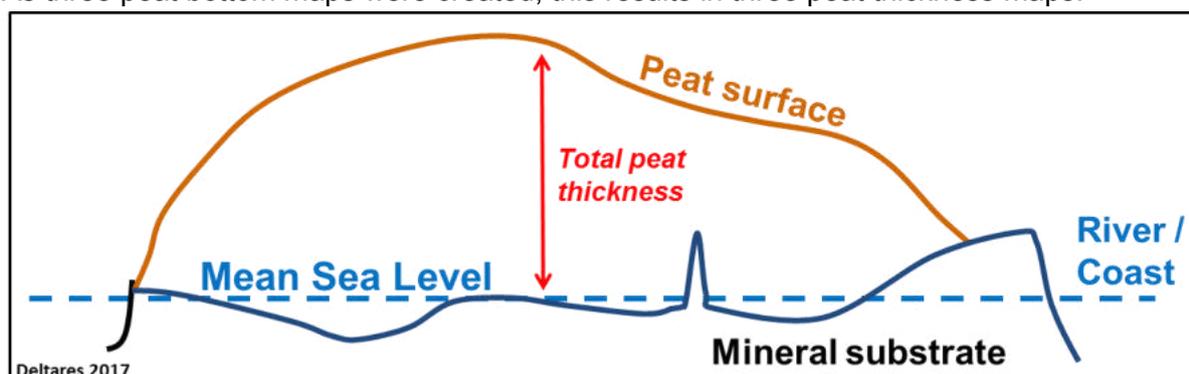
Figure 7 Illustration of how peat thickness is determined as the difference from the peat surface and depth of the peat bottom (interface with the mineral substrate).

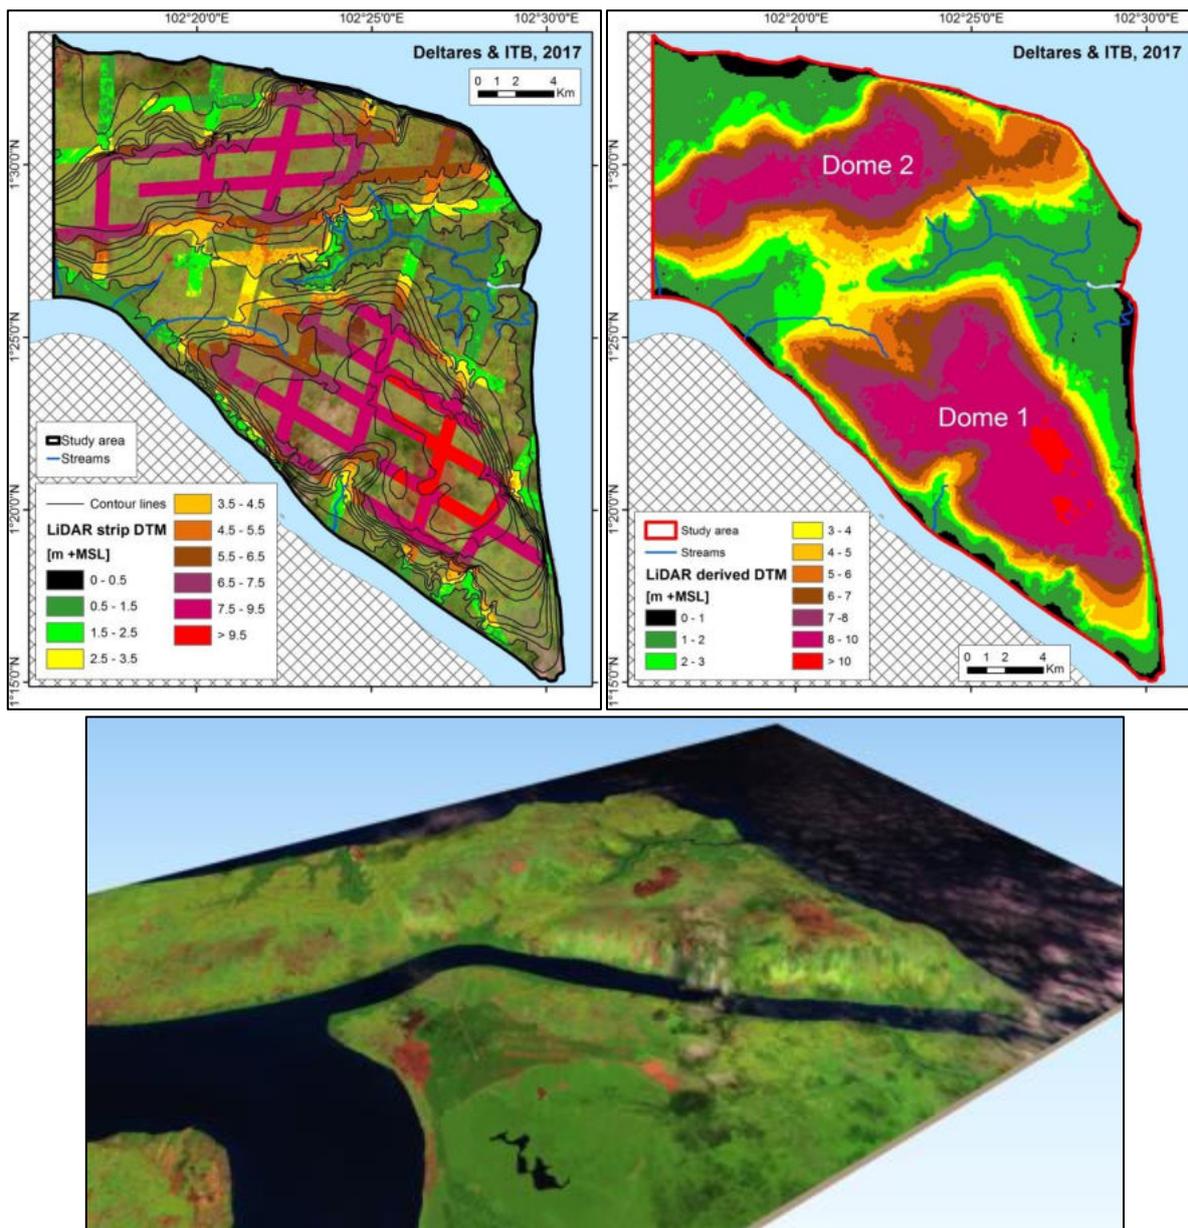
Figure 8 (TOP LEFT) LiDAR strip + manually drawn contour lines and (TOP RIGHT) LiDAR derived DTM (100 m spatial resolution) for the study area (interpolated using LiDAR strip and contour lines) showing 2 distinct peat domes (Dome 1 and Dome 2). (BOTTOM) a 3D representation of the DTM with a Sentinel-2 composite image of 6 August 2016 superposed on it.

The DTM that was generated from filtered LiDAR data and contour lines (Figure 8) shows two distinct peat domes separated by streams that flow East and West. These domes are named Dome 1 and Dome 2 for the Southern and Northern domes respectively (Figure 8). Dome 2 extends into the Western part of Bengkalis Island, outside of the study area.

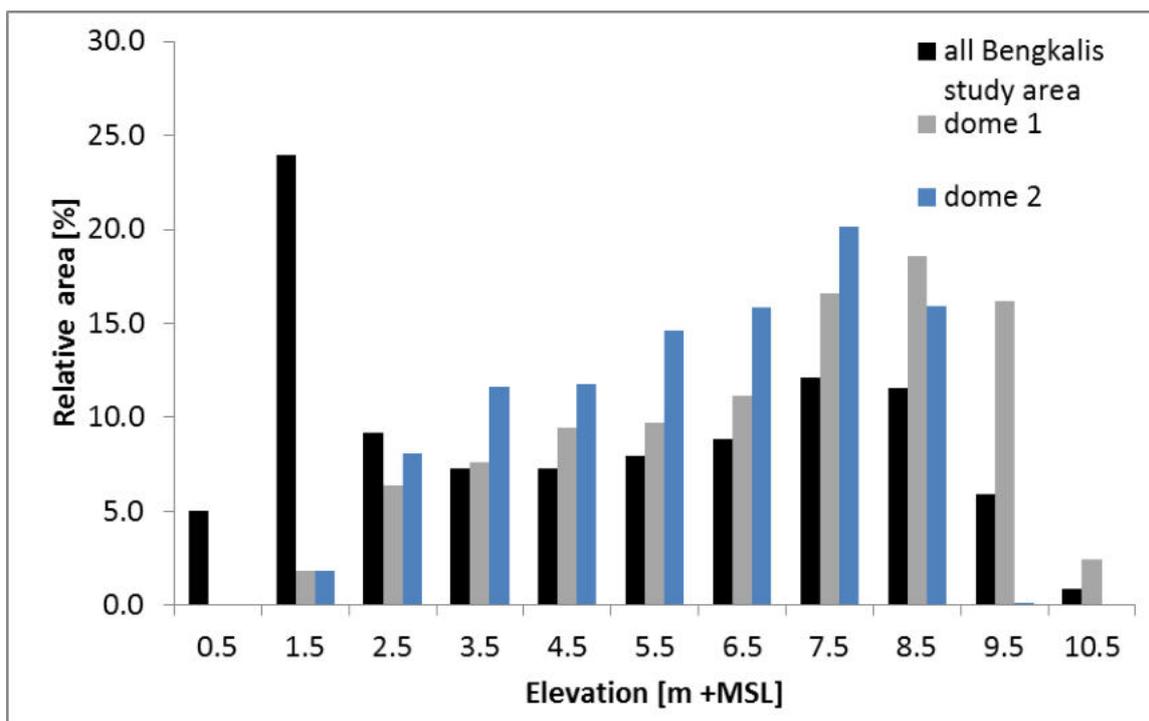
Figure 9 Relative distribution of surface elevation in the LiDAR-derived DTM, for the whole study area, as well as for the 2 peat domes (using the extent derived from peat thickness model (method 1), Figure 22).

The average elevation of the LiDAR strip data after filtering (removal of vegetation signal) was 5.50 m +MSL with a standard deviation of 2.80 m. Figure 9 presents the elevation distribution in the study area determined from the LiDAR DTM shown in Figure 8. The DTM derived from the filtered LiDAR data and contour lines shows that 157 km² or 29.0 % of the study area surface is below 2 m above MSL, and 213 km² or 39.3 % is more than 6 m above MSL. In Dome 1, these numbers are 126 km² and 65.0 %; in Dome 2 they are 84 km² and 52.0 % (Table 1).

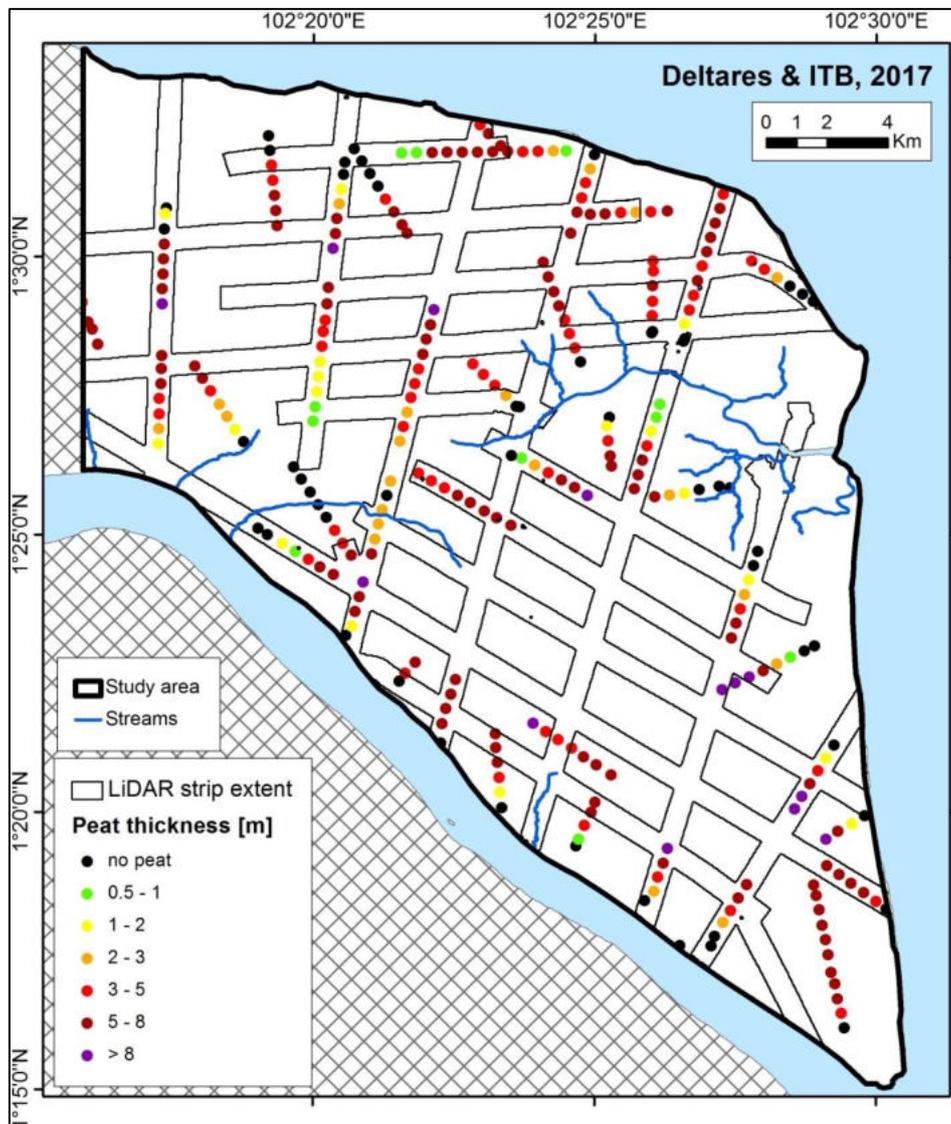
Figure 10 Peat thickness measurements in the study area as surveyed between 16 March to 20 April 2017. Also shown is the extent of the LiDAR strip data (Figure 8).

Of the 284 survey locations, 274 locations were within the study area (Figure 10). Of these 274 locations, 221 (80.7%) found the presence of peat i.e. an organic top soil horizon of over 0.5 m thickness. For 2 of these locations the mineral subsoil was not reached since not sufficient extensions were brought to the field. These locations were not re-surveyed at a later time and are removed from further calculations (see also Annex 1). Of the remaining 219 locations, 95.0% found a peat thickness of over 1 m and 77.6% over 3 m. Average peat thickness of the 219 locations is 4.79 m with a standard deviation of 2.17 m (Table 2).

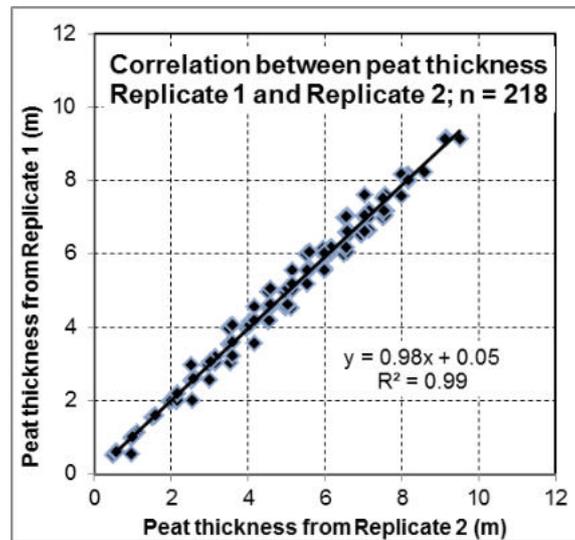
Figure 11 First and second replicate peat thickness field measurements plotted against each other (n = 218).

The fit between first and second replicates in each measurement is very good with an R^2 of 0.99 and an average absolute difference of 0.05 m (Figure 11), indicating that the quality of peat thickness measurements collected in this survey is high.

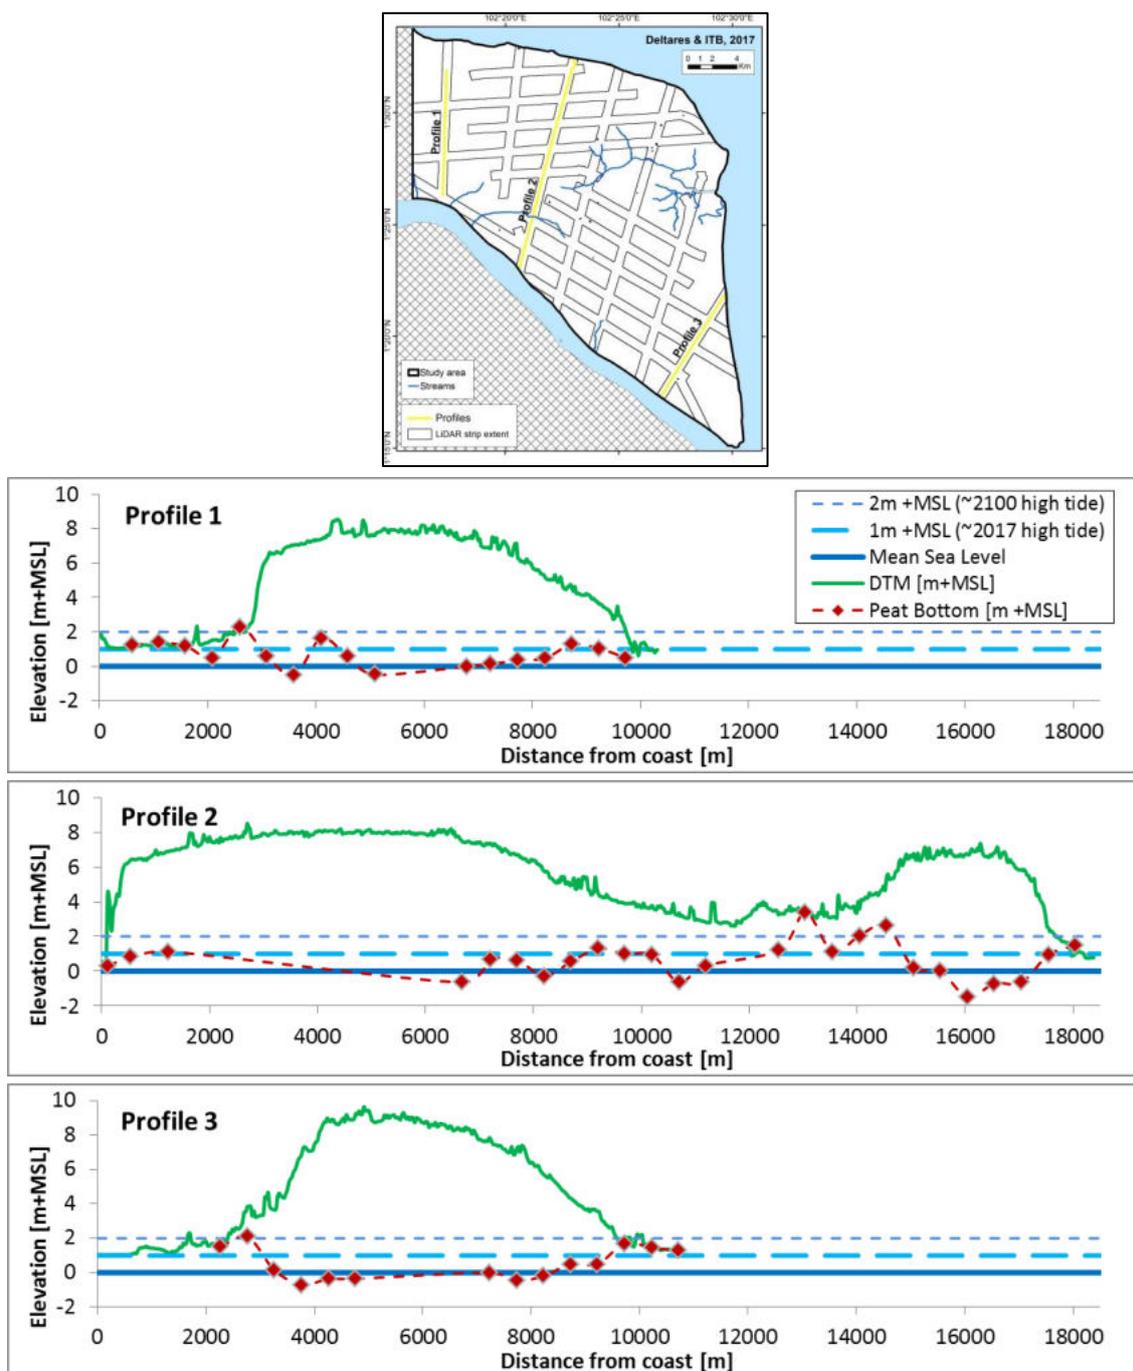
Figure 12 Three cross sections over the two Bengkalis Island peat domes along LiDAR flight lines, showing LiDAR derived surface elevation (DTM) and the peat bottom as derived from field measurements. The North side is on the left in all profiles. Mean Sea level and estimated likely High Tide levels are also shown. *Note:*

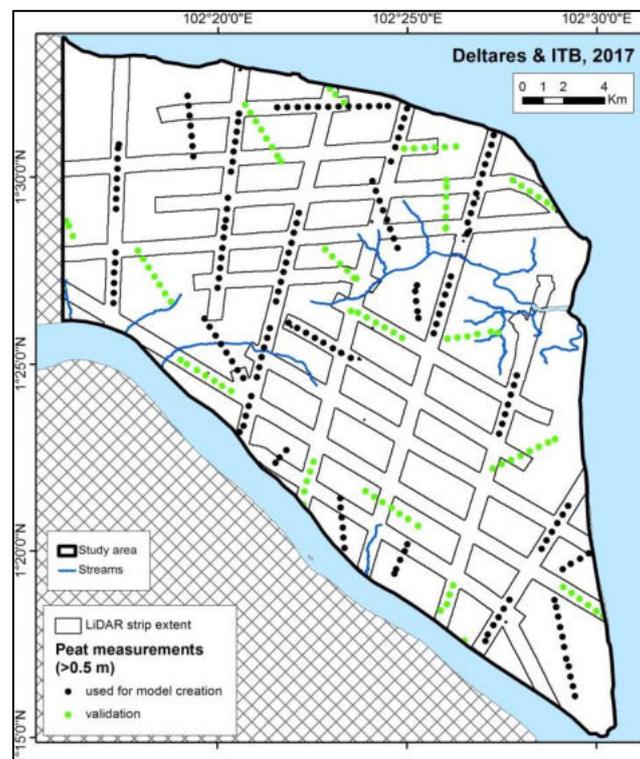
Figure 13 Distinction between peat thickness measurements in the study area (Figure 10) used further in peat thickness model creation (black dots) and as used for validation. Also shown is the extent of the LiDAR strip data (Figure 8).

The peat thickness range, and the fit with the peat surface DTM, of measurements that were used for model creation (Figure 13) was almost identical to that of measurements that were used for validation, as is shown in Figure 16.

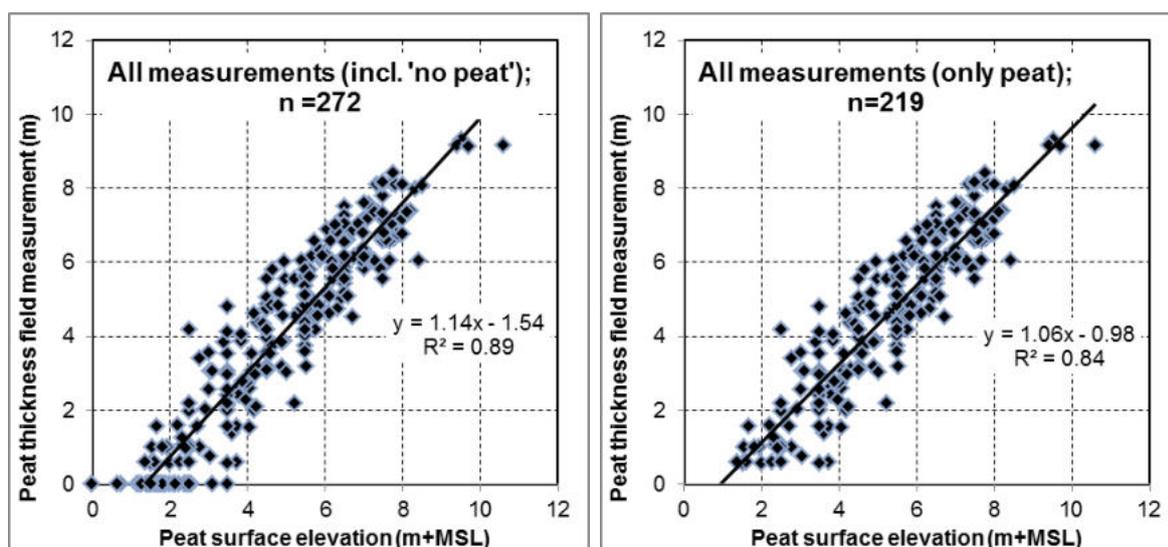
Figure 14 Peat thickness measurements plotted against elevation as determined from LiDAR DTM. (LEFT) including all (incl. 'no peat') measurements, (RIGHT) including only peat measurements.

A very close fit was found between surface elevation above Mean Sea Level as derived from the LiDAR DTM (Figure 8) and peat thickness measurements (Figure 10), with an R^2 value of 0.84 for all data combined if 'no peat' measurements are excluded (Figure 14). This confirms that the peat bottom is relatively flat, as found in most coastal peatlands in Indonesia, and that a surface DTM can be used for peat thickness mapping.

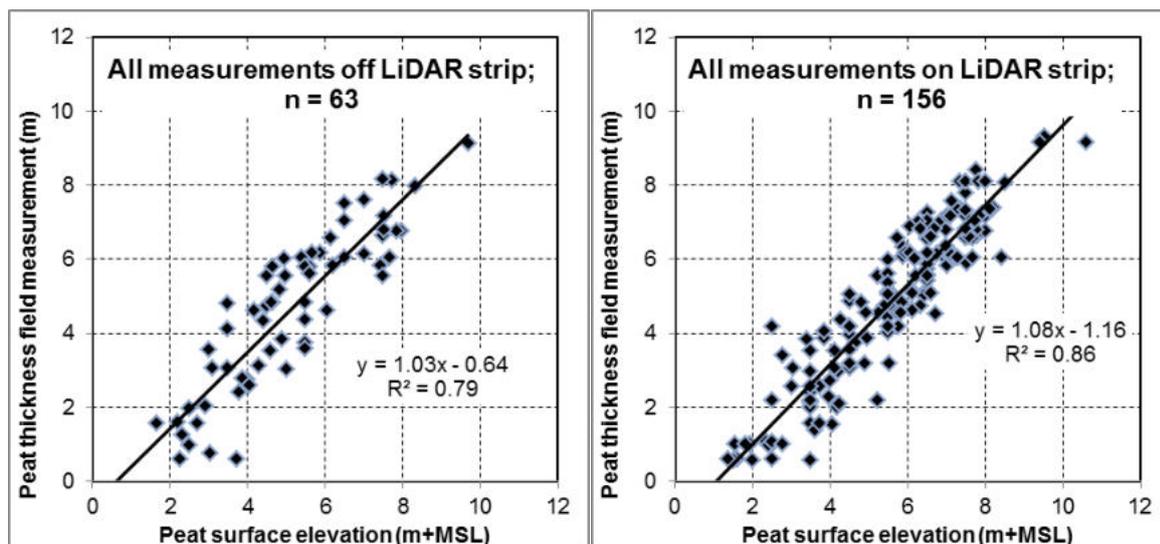
Figure 15 Peat thickness measurements (LEFT) ‘on the LiDAR strip’ and (RIGHT) ‘off the LiDAR strip’ plotted against elevation as determined from LiDAR DTM.

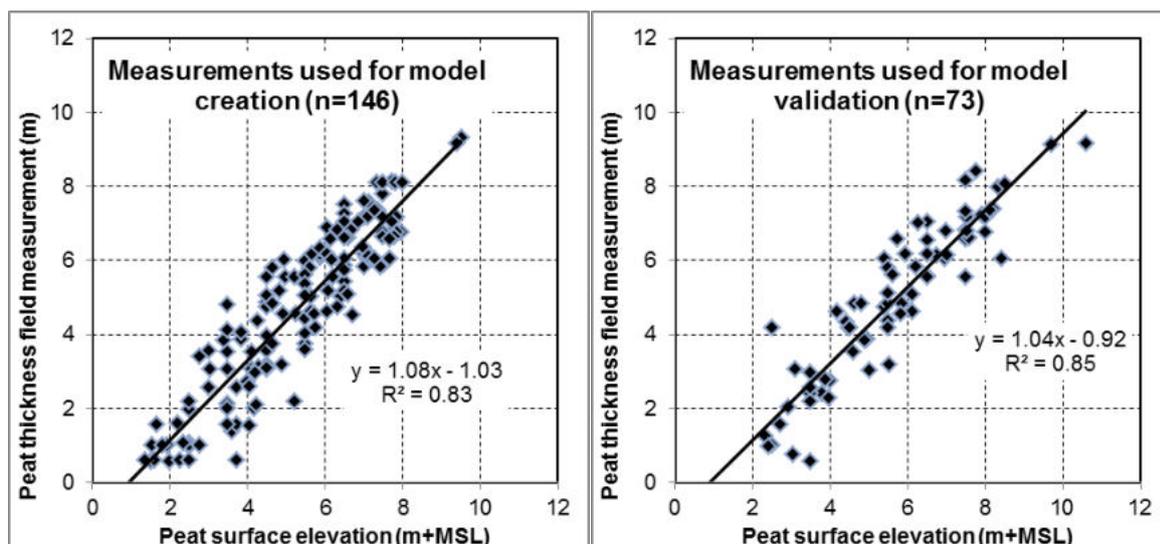
Figure 16 Peat thickness measurements used to create the peat thickness model (LEFT), and those used to validate the model (RIGHT) plotted against elevation as determined from LiDAR DTM.

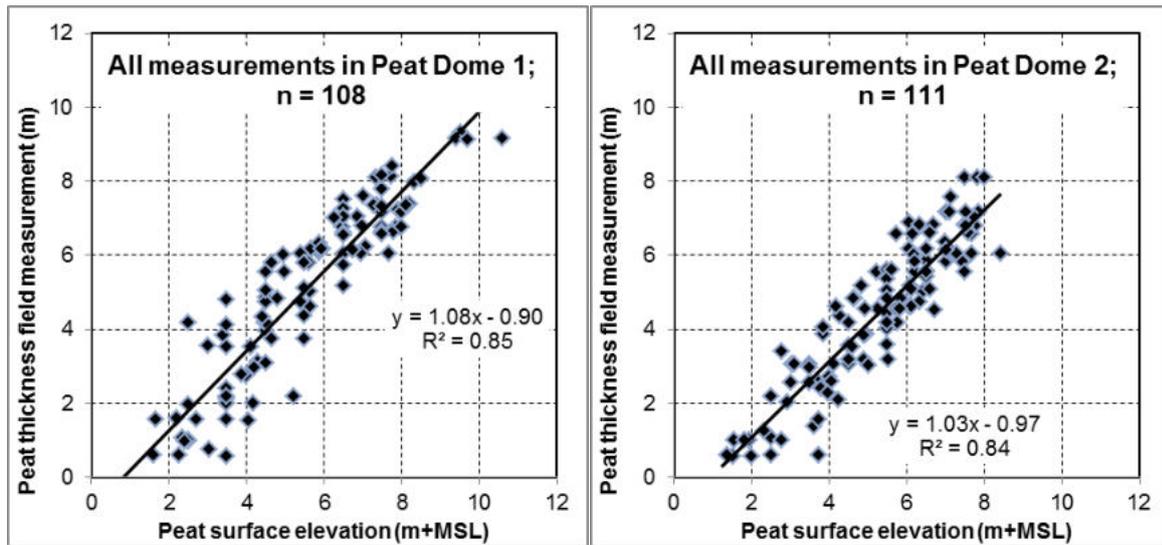
Figure 17 Peat thickness measurements in the two domes that occur in the study area (see Figure 8) plotted against elevation as determined from LiDAR DTM.

Finally it was investigated whether the relation between peat thickness and peat surface DTM was fundamentally different between the two domes, as they have somewhat different settings in the landscape. The number of peat thickness measurements in Dome 1 and Dome 2 is similar, at 108 and 111 respectively. It was found that, despite these differences, the peat thickness distribution and also the underlying relation between peat thickness and DTM was nearly identical for the two domes (Figure 17). Average and maximum peat thickness from field measurements are 5.08 / 9.33 m and 4.51 / 8.09 m respectively (Table 2).

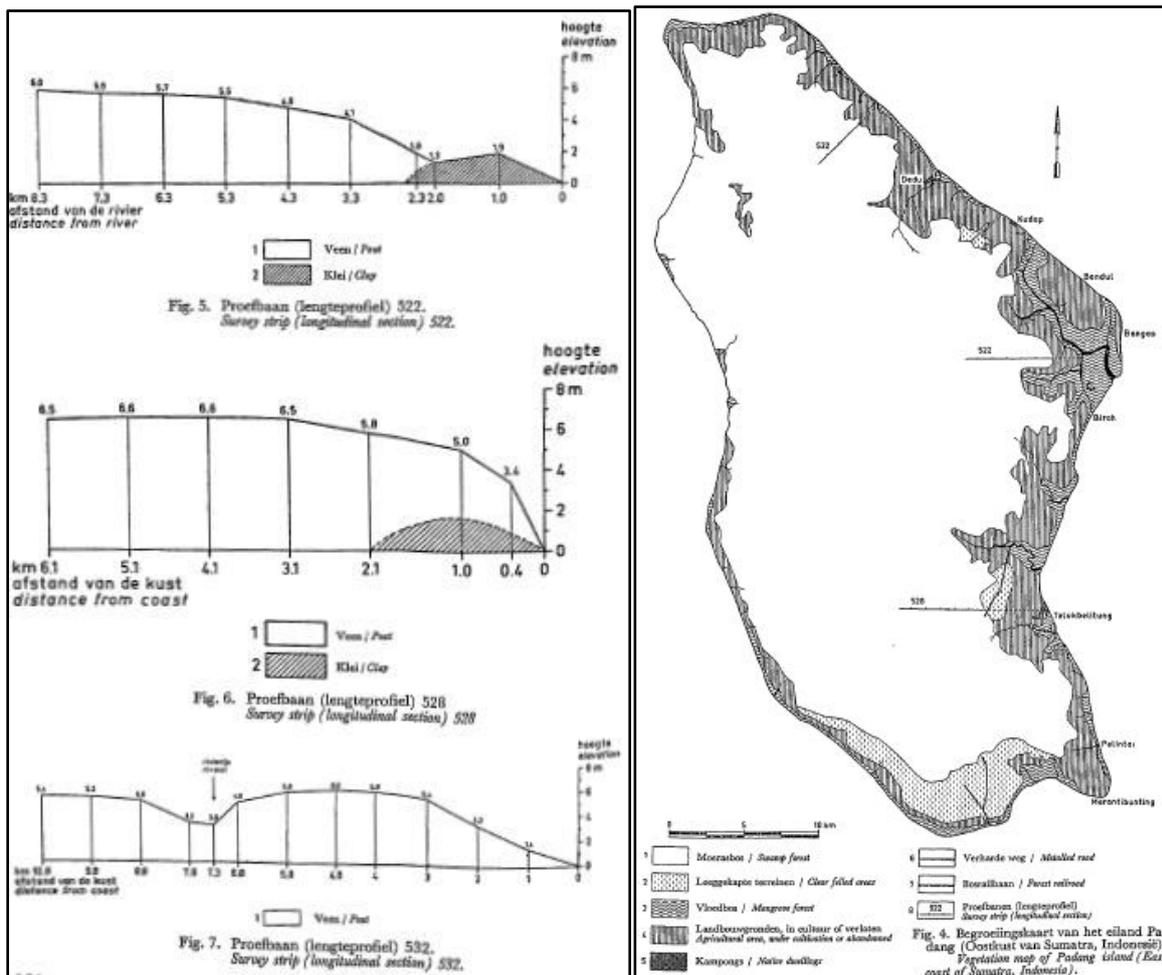
Figure 18 Cross sections through coastal peatland on Pulau Padang, adjoining Bengkalis Island, as published by van Doorn in 1959. This study applied the principle that the peat bottom in such areas is relatively flat compared to the peat surface.

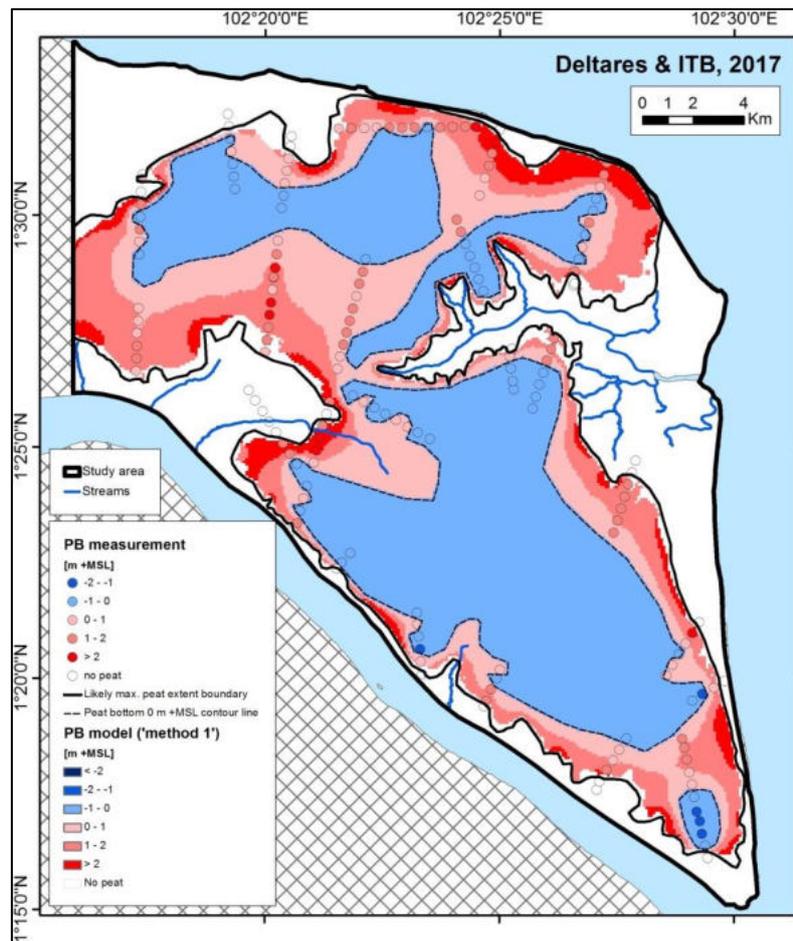
Figure 19 Peat bottom model as derived from subtracting actual field peat thickness measurements (Figure 13; black dots) and the LiDAR based DTM (Figure 8); the 0 m +MSL contour lines are added manually between measurements. The peat bottom map is created through inverse distance interpolation between peat bottom measurements, the 0 m +MSL contour lines and the likely maximum peat extent boundary.

In Figure 19 the peat bottom model is shown resulting from the interpolation between peat thickness measurements subtracted from the LiDAR derived DTM, manual drawn peat bottom contour lines and the likely maximum peat extent boundary. It should be noted that the peat bottom model shown in Figure 19 already accounts for the 'no peat' area as shown in Figure 22 resulting from the difference between the LiDAR derived DTM and the 'full' peat bottom model.

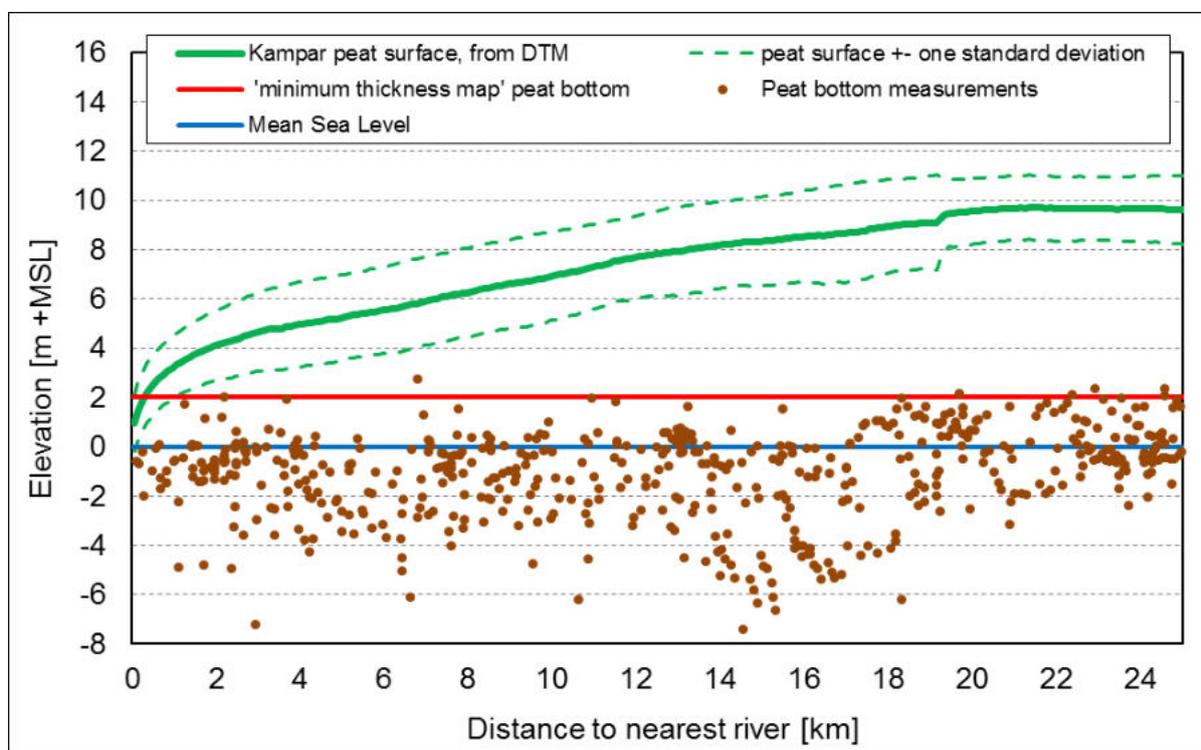
Figure 20 Virtual cross section through the Kampar Peninsula (KP) peatland, near the Bengkalis study area, in Riau (from Hooijer *et al.*, 2015b). The cross section presents the average of all peat bottom (from field surveys) and surface elevation (from LiDAR DTM) points on the KP. The peat bottom here is usually near Mean Sea Level, but more commonly below it than above it. Note that the peat thickness measurements available for the Kampar Peninsula are from several sources, some with unclear survey protocols and no metadata. Such data must be considered with caution, and may explain part of the large variation in peat bottom elevation seen in this graph.

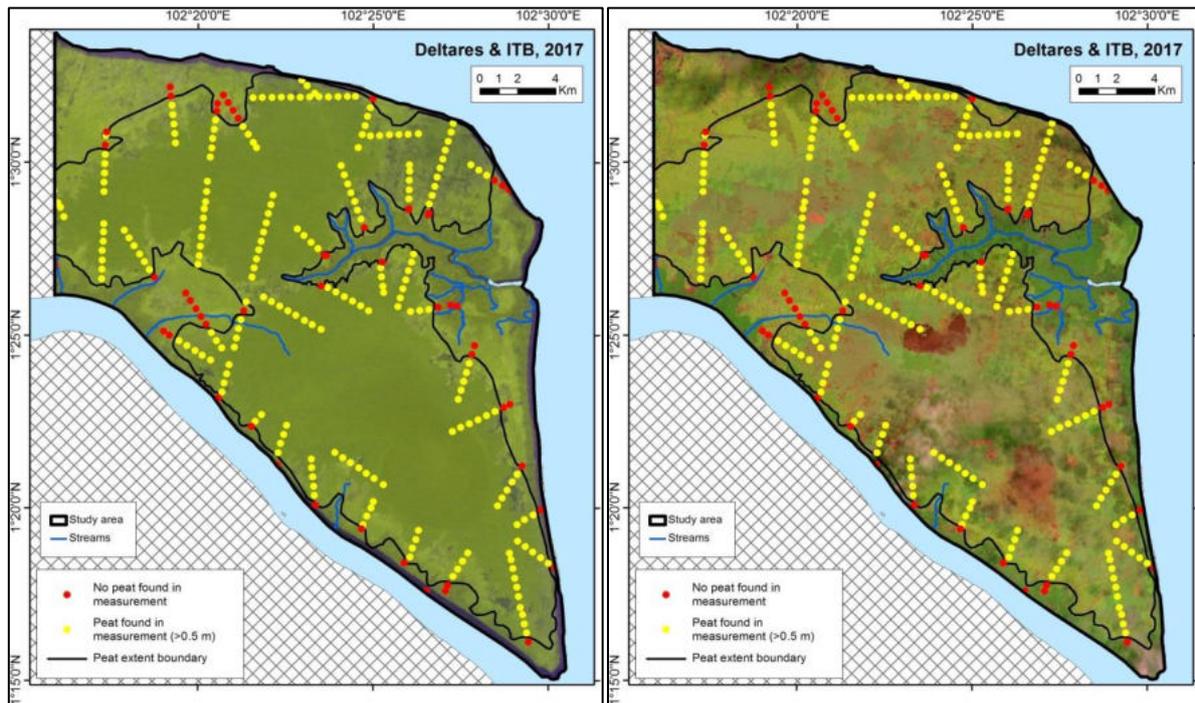
Figure 21 Likely maximum peat extent boundary in the study area delineated based on visual interpretation of (TOP) background RGB composite (spectral bands 6-7-5) Landsat-1 image of 5 October 1972 and peat thickness measurements (yellow and red dots). For comparison the likely maximum peat extent boundary is also shown on (BOTTOM) Sentinel-2 background RGB image of 4 August 2016 (spectral bands 11-8-5). Note that nearly all peat was still forested in 1972.

The likely maximum peat extent boundary was mapped through visual interpretation of a composite Landsat-1 image of 5 October 1972 (i.e. when the area was still forested and peat extent can be discerned from vegetation patterns; Figure 21) combined with the location of 53 'no peat' measurements found during the 2017 peat thickness survey (Section 3.2).

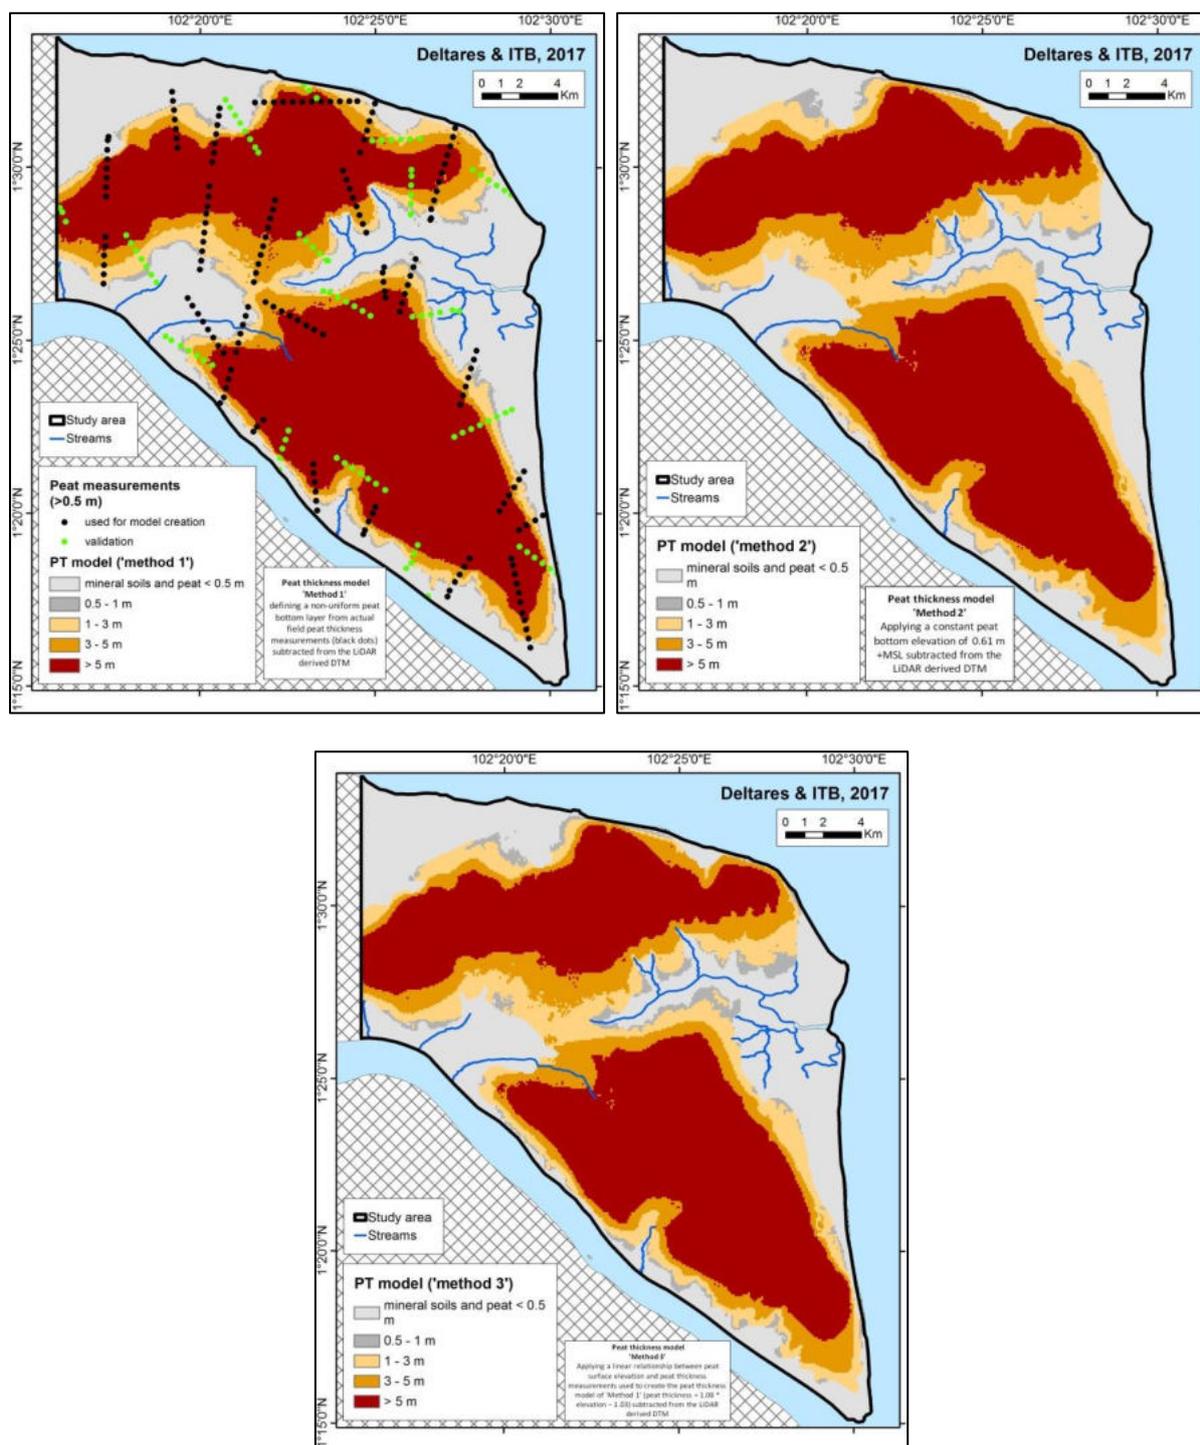
Figure 22 Peat thickness models as derived from LiDAR based DTM (100 m spatial resolution), applying three different methods:

- Method 1: Defining a non-uniform peat bottom layer from actual field peat thickness measurements (black dots).
- Method 2: Applying a constant peat bottom elevation of 0.61 m +MSL (Table 2).
- Method 3: Applying a linear relationship between peat surface elevation and peat thickness measurements used to create the first peat thickness model (peat thickness = 1.08 * elevation - 1.03) (Figure 16).

The results of the different DTM based peat thickness mapping methods (Figure 22) are quite similar. This is because the variation in peat bottom elevation is much less (in the order of 10-20 %) than that in peat surface elevation. Therefore, the peat surface shape dominates the peat thickness model whatever approach is taken to mapping the peat bottom elevation.

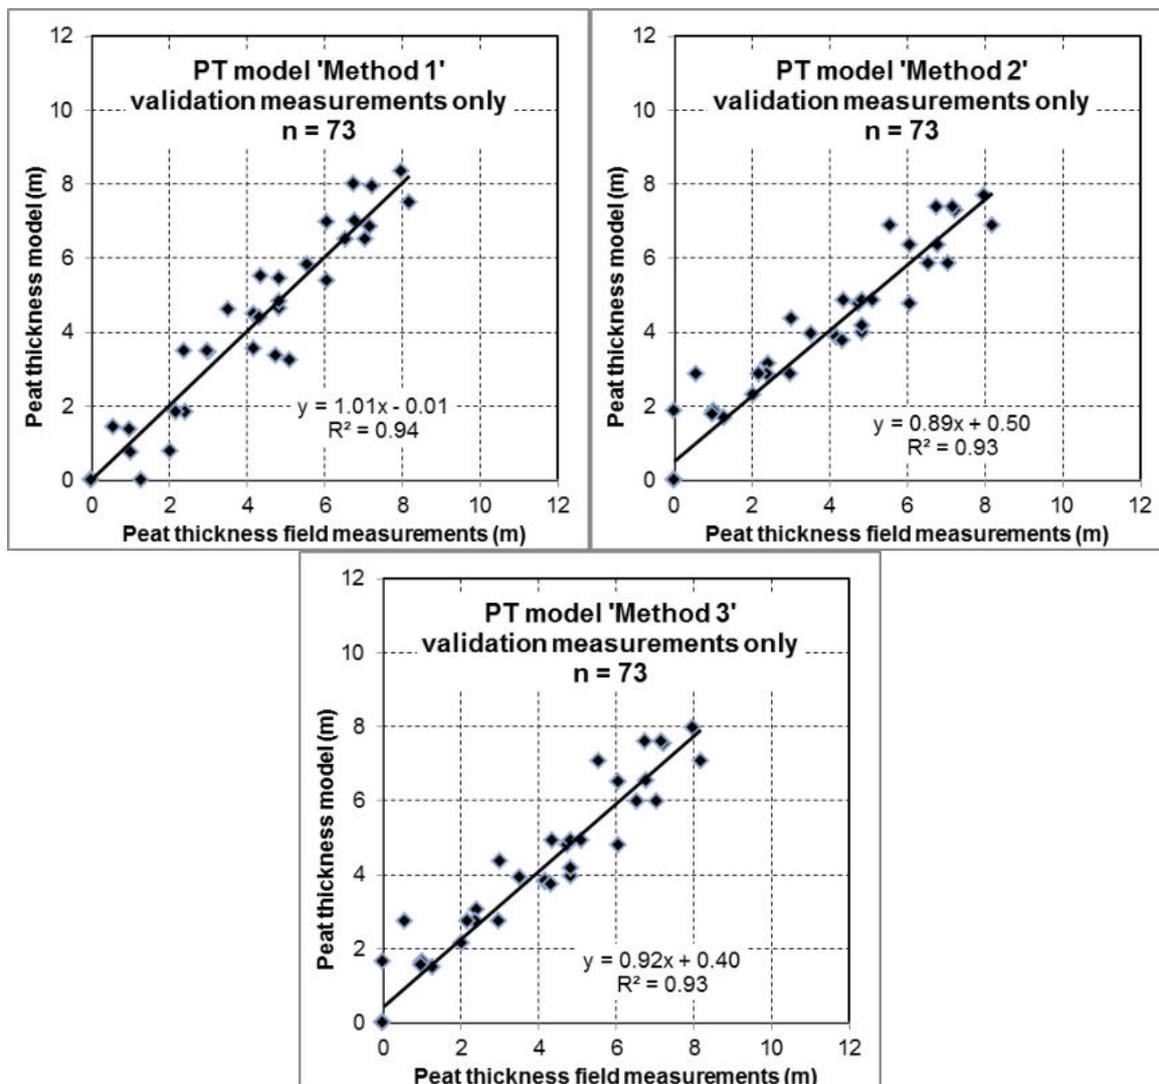
Figure 23 Modelled peat thickness plotted against peat thickness measurements (the 'validation' dataset (Figure 13) for the 3 different peat thickness models.

The three approaches yield somewhat different results, with the outcome of the first method deemed to be somewhat more accurate with an R^2 against field measurements of 0.94 which is slightly higher than the other two model results (0.93), and with an intercept through '0' (Figure 23). However, it should be noted that the peat bottom in most of the area is below 1 m +MSL and therefore below the flood limit. In other words: even as peat continues to disappear after drainage, the peat bottom in most of the area can never be at the land surface, as the land will be flooded before the mineral substrate can be exposed. It is therefore questionable whether knowing the exact peat thickness, i.e. the exact position of the peat bottom below the flood limit, always warrants much extra effort and investment in field surveys.
