Peatland mapping for Bengkalis Island, Riau, using limited LiDAR data and peat thickness field measurements

Submission by Deltares and ITB (Team Deltares)
to
Indonesian Peat Prize

Indonesian Peat Prize - Solution Development Phase

Final Report, June 2017

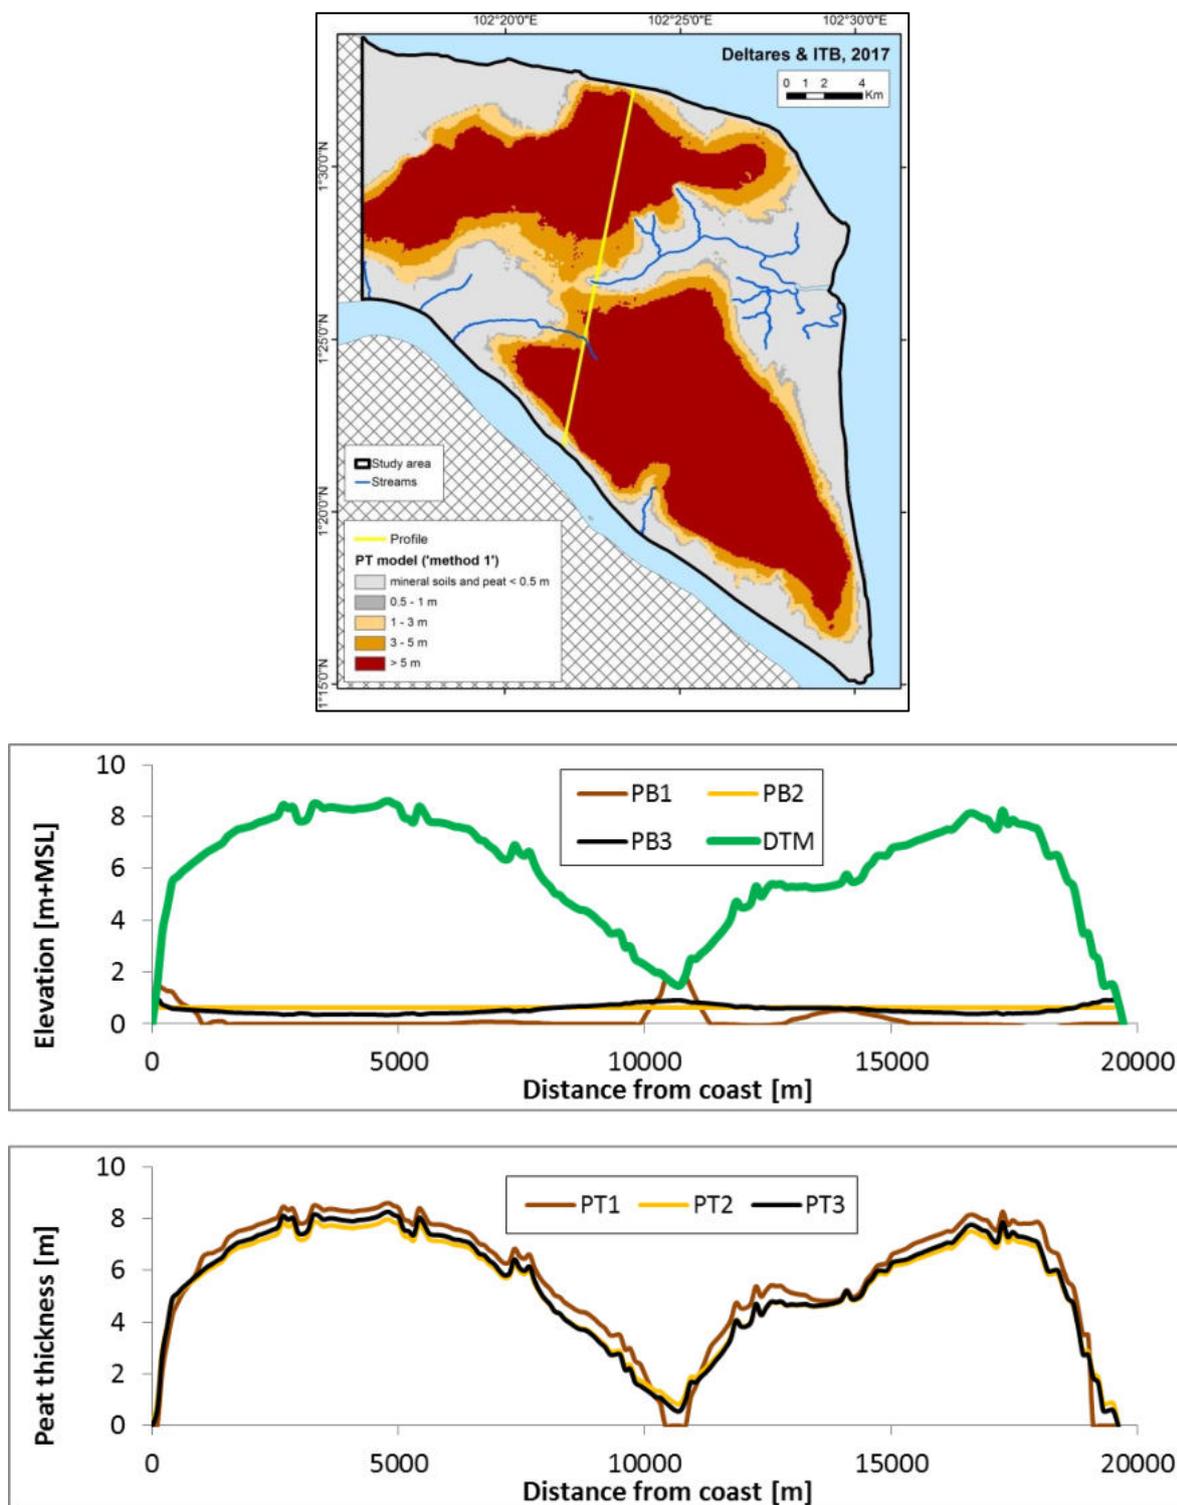
Figure 24 Cross section through the two Bengkalis peat domes showing LiDAR based peat surface elevation (DTM), peat thickness and peat bottom elevation according to 3 peat models. For methods see caption in Figure 22.

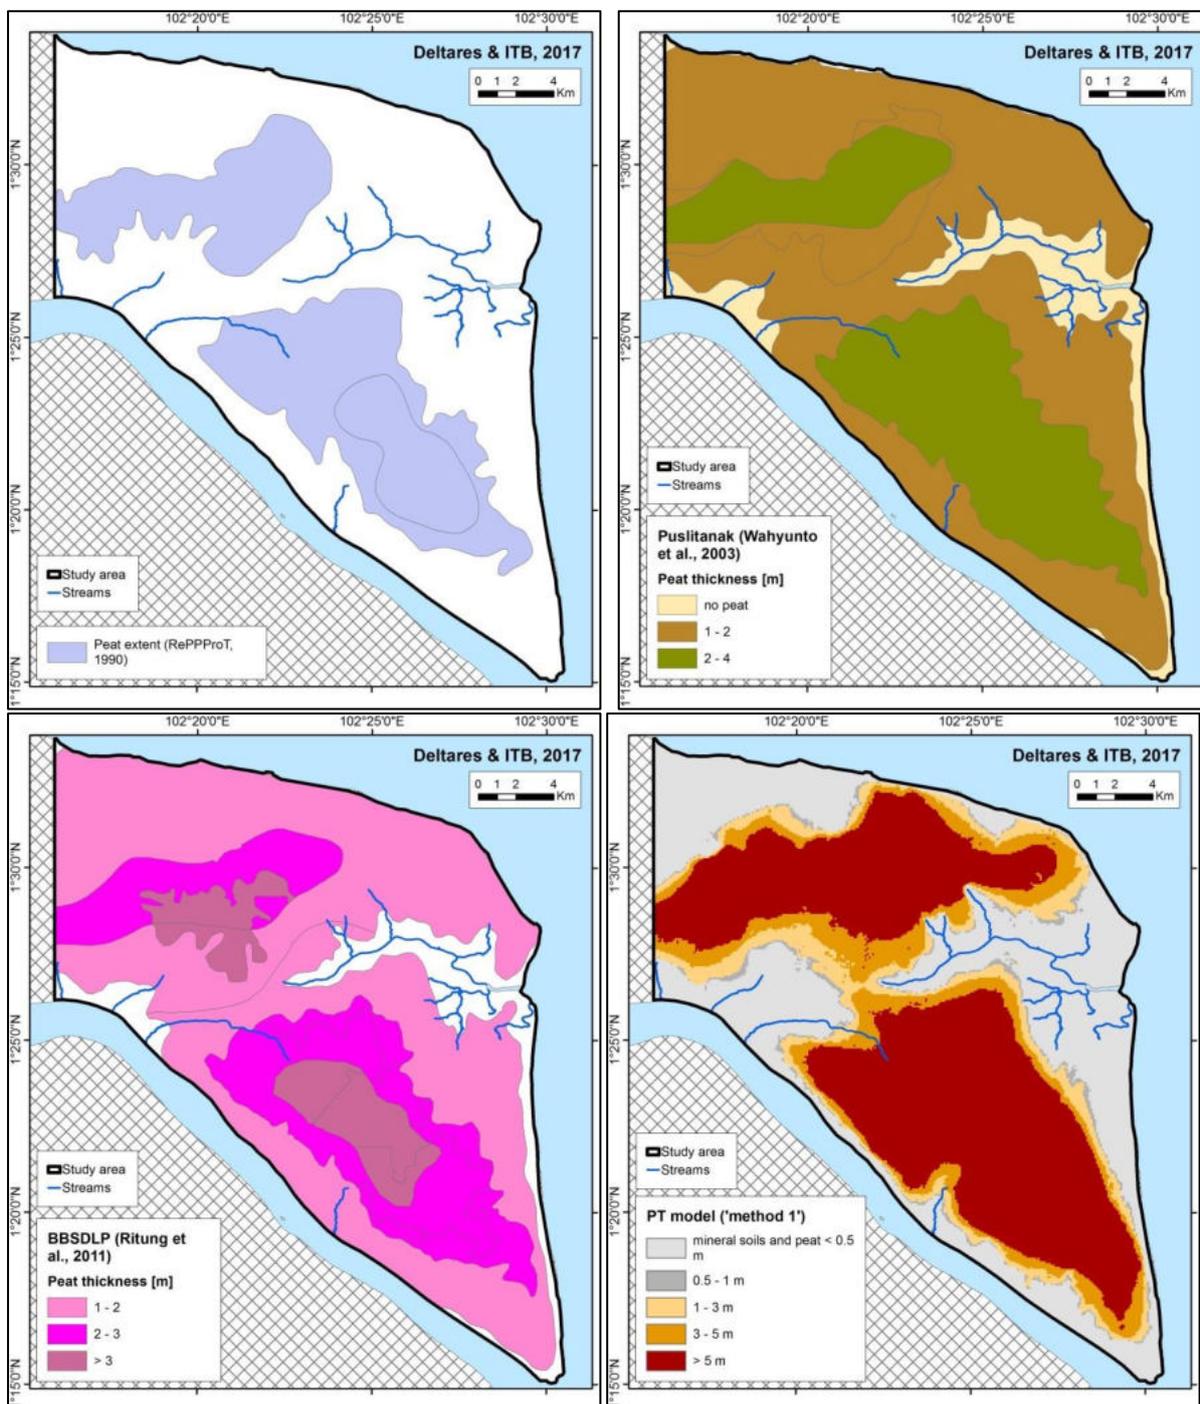
Figure 25 Three existing peat extent (and thickness for Puslitanak and BBSDLP) maps for the Bengkalis study area. (TOP LEFT) RePPPProT (1990), (TOP RIGHT) Puslitanak (Wahyunto *et al.*, 2003) and (BOTTOM LEFT) BBSDLP (Ritung *et al.*, 2011). For comparison also PT model 1 (Figure 22) is also shown (BOTTOM RIGHT).

The three existing models all show two distinct domes, as was also found in this study. The 2003 and 2011 maps present the same peat extent, that is far larger than the extent in the 1990 map and also substantially larger than the extent found in this study. However, the extent of the deepest peat in the 2003 and 2011 maps (2-4 m and >3 m respectively) is far less than what was found in this study, less than half of the >3 m area (Table 5). It is clear that the peat extent and thickness map presented by Deltares and ITB is a large improvement on existing maps.

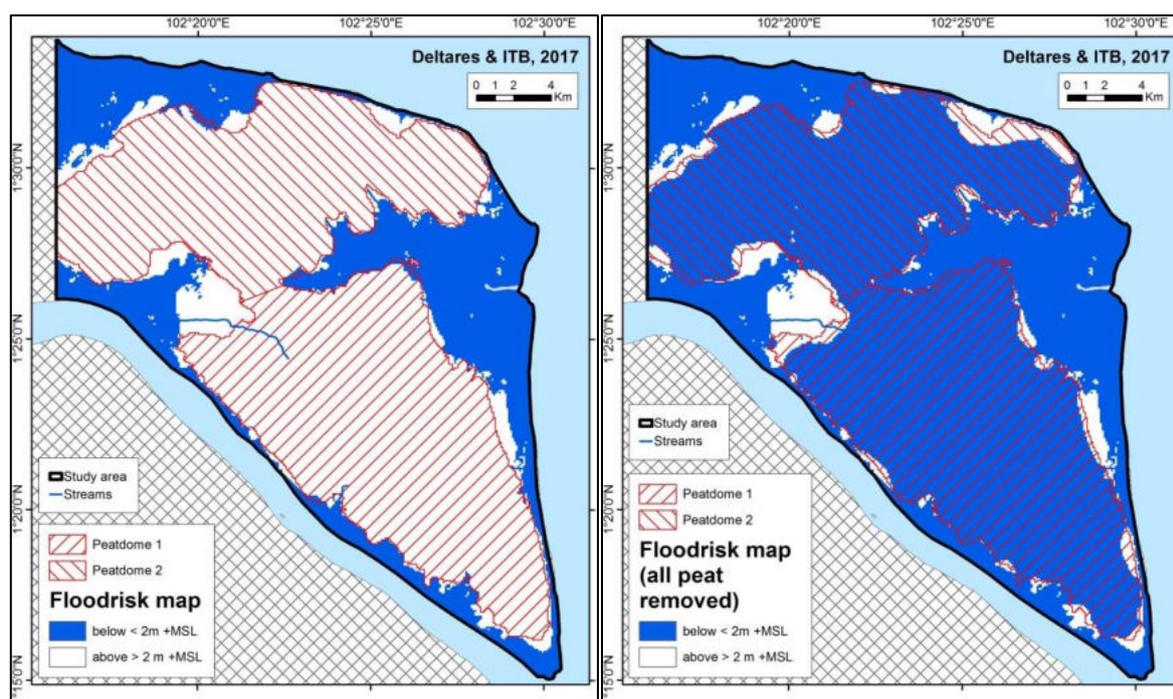
Figure 26 Land surface below 2 m +MSL in 2017 (LEFT), as determined from the LiDAR based DTM, and (RIGHT) after removal of all peat following drainage.

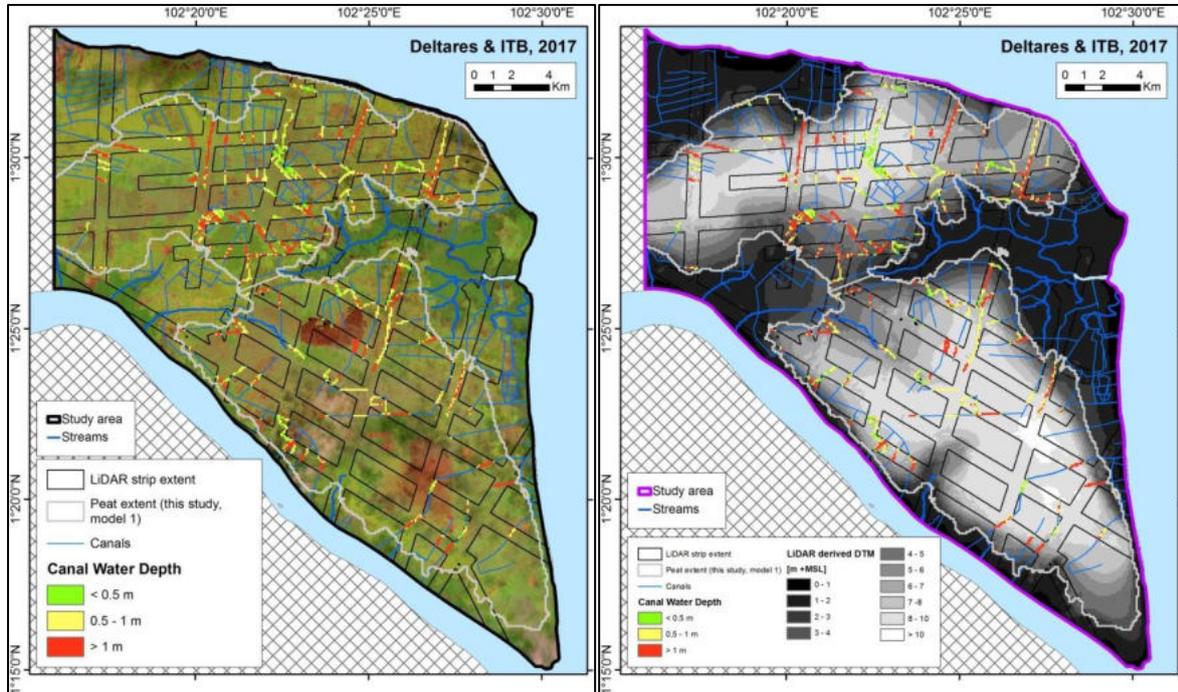
Figure 27 Canal water depth below the surrounding land surface on peatland, for 6-7 November 2016, as determined from LiDAR data.

It should be noted that, in intensively drained areas, ground water depths can be easily estimated from CWD, as water tables in deep peat are relatively uniform due to the very high hydraulic conductivity of fibric and hemic tropical peat (usually > 10 m/day).

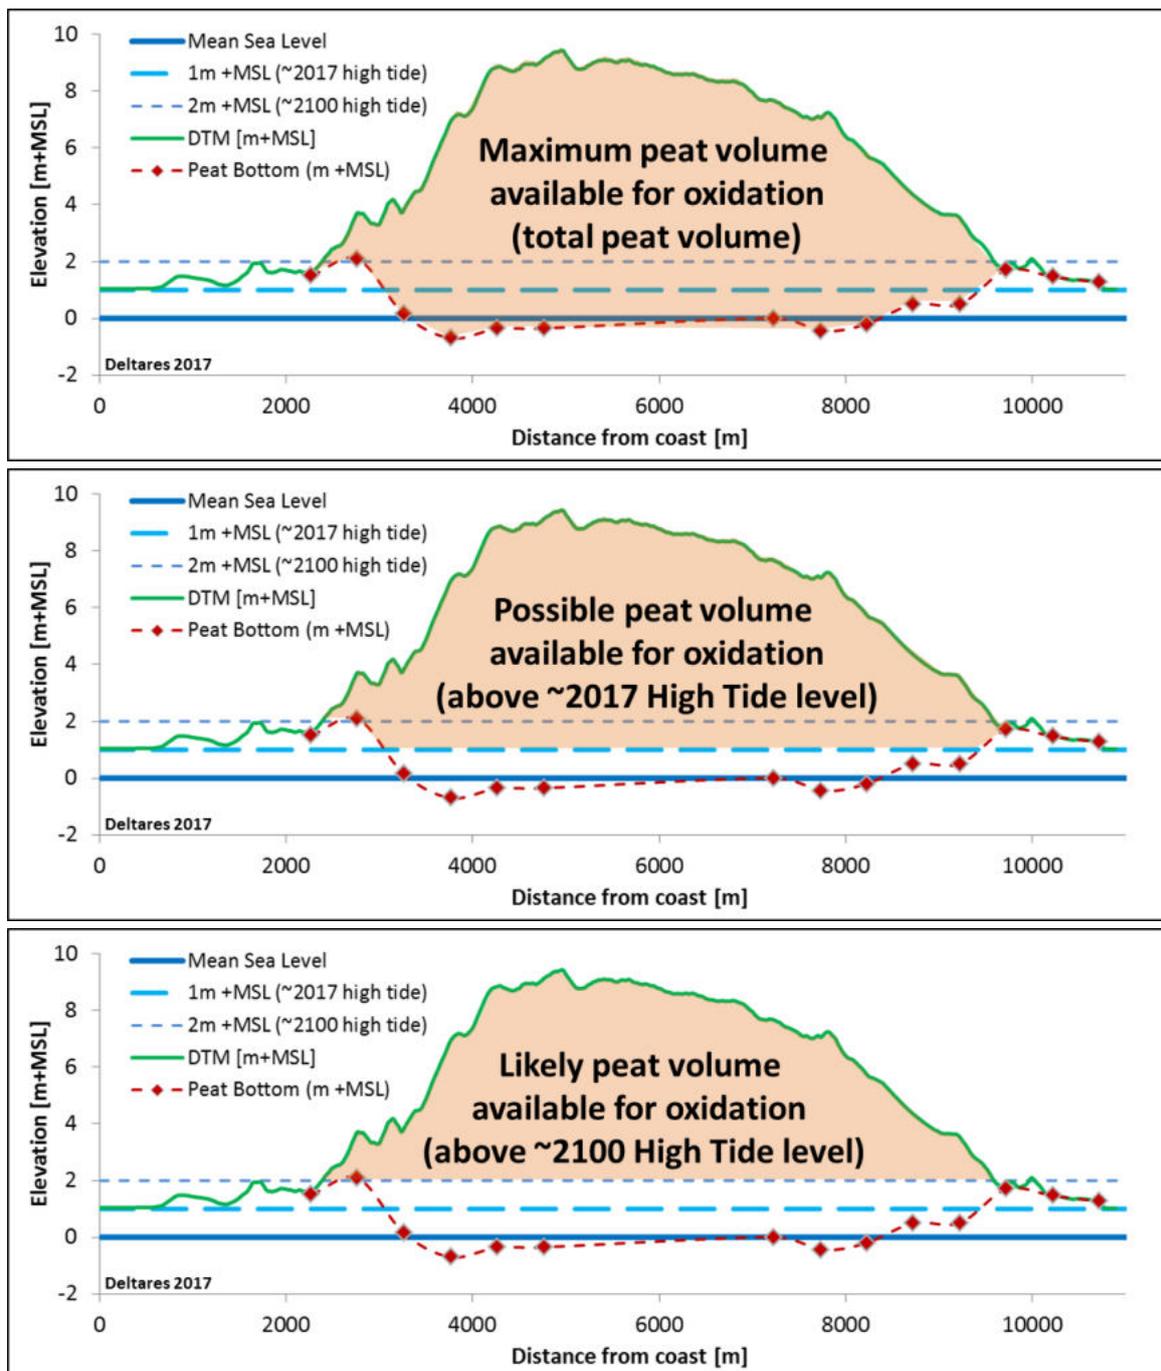
Figure 28 Schematic illustration of how only part of a peat deposit may be available for oxidation including fires.

It should be considered that only part of a peat deposit may be available for oxidation including fires. Peat that is below the permanent water table will always be water saturated and can therefore never decompose or burn (although it may be eroded by waves in coastal settings). The position of the permanent water table depends on Sea / River level, which changes with Sea Level Rise, and also on distance to Sea or River as a conveyance gradient is required to remove water from the peat surface (DID, 2001; Hooijer *et al.*, 2015b). Thus, it should be considered that a substantial amount of peat may be excluded from carbon stock calculations (Figure 28), and that knowing the depth of peat below the permanent water table may be less relevant. Likewise, for land suitability assessments for agriculture, it is often not relevant to know the depth of peat below the permanent water table.

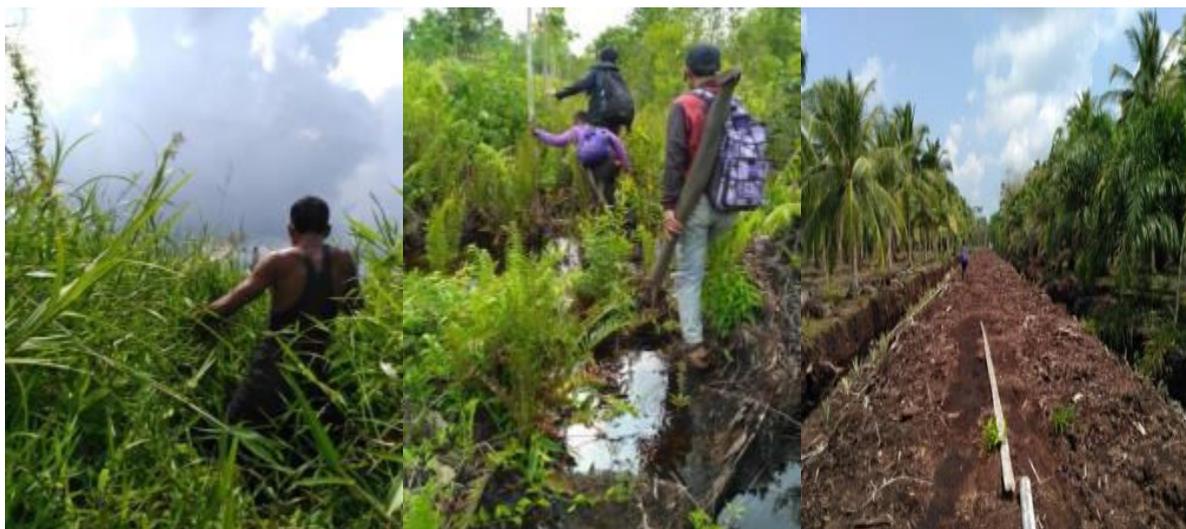
Figure 32 Different types of land cover needed to be crossed to reach the sample location.

One factor affecting the number of team members was the land cover and accessibility of sample point locations (illustrated in Figure 32). For areas which could not be easily reached and required 'rintisan', additional local workers were hired. A list of local field team members for each day, together with the list of names of additional local field workers from every village are provided in Table 9. In general, each of the two field teams consisted of one team leader (from ITB) and 2 to 4 local workers, supervised by Mrs. Rizka Akmalia of Deltares, who was supported by Mr. Dedi Mulyadi. The main field team (present during the whole survey) consisted of 2 team leaders from ITB (Mr. Odie Syarozie and Mr. Isfan Anugrah) and 2 local workers from Desa Penebal (Pak Udin and Pak Anto).

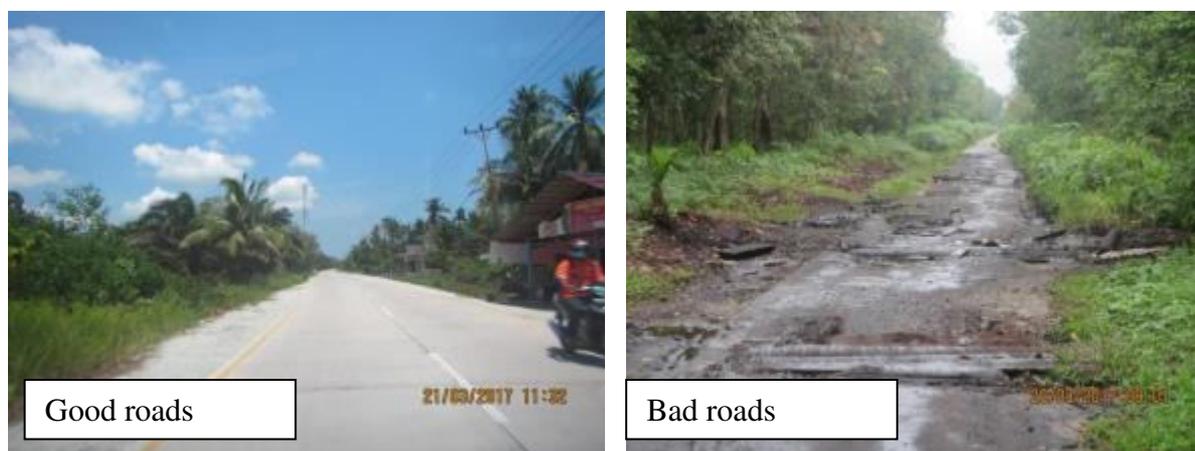
Figure 34 Illustration of ‘good’ and ‘bad’ roads encountered during road reconnaissance survey from 22-23 March 2017.

During the reconnaissance survey, road access was mapped using GPS tracking (Figure 33). Because the quality of the roads was not always good (Figure 34), some villages could not be easily reached. To reduce daily mobilization time (and increase field time) it was decided that the field teams needed to move basecamp several times. Based on road accessibility and accommodation availability, the survey area was divided into three sectors; West, South, and North (Figure 33).

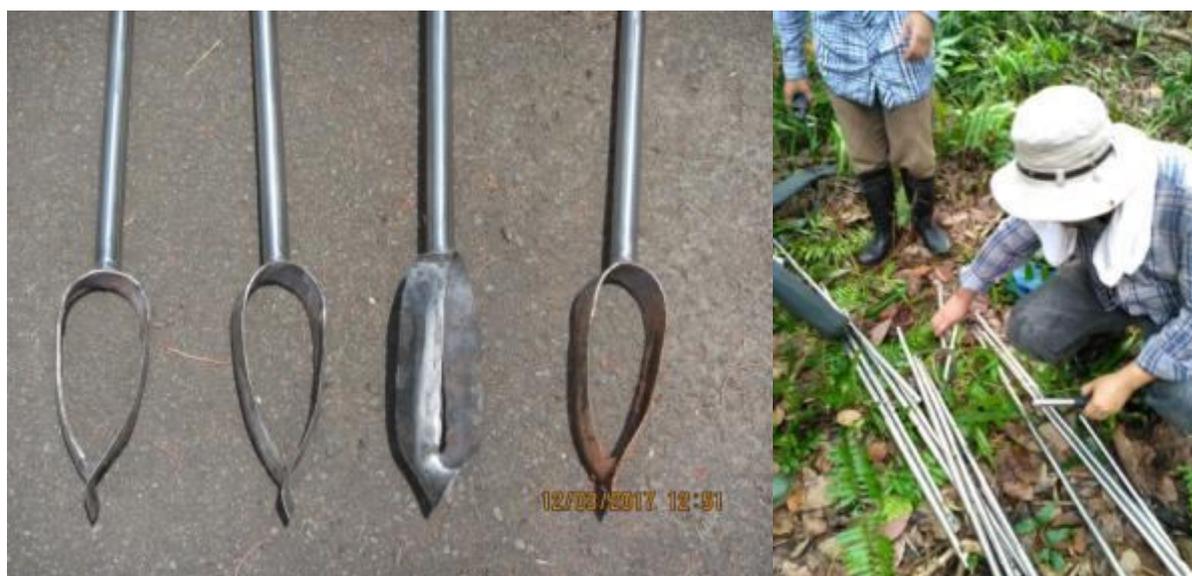
Figure 37 (LEFT) Edelman type auger heads used in this peat survey. (RIGHT) team preparing the auger at the survey location.

The peat thickness field survey was carried out following a field protocol (SOP; Annex 2). Peat thickness was measured using an Edelman type auger. At the first stage of the survey three replicate measurements were taken at every sample location, at 1 m apart, to be able to investigate variation and error sources; this was later reduced to 2 measurements when differences between replicate results were found to be small. The peat thickness measurement used for analysis was the average of the replicate measurements.

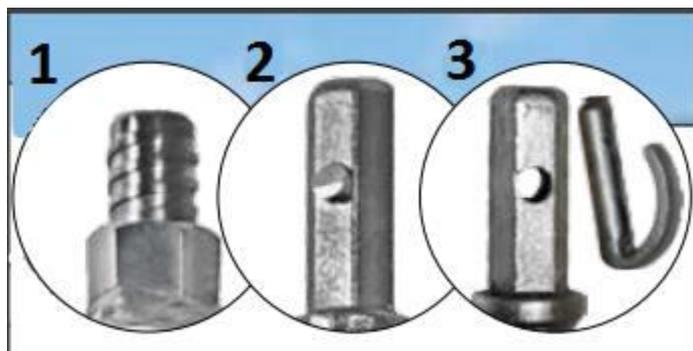
Figure 38 Different types of connector: (1) nut-bolt, (2) button-hex, (3) C-clip ((source: www.precisionagrilab.com/Documents/AMSSoilProbes.pdf).

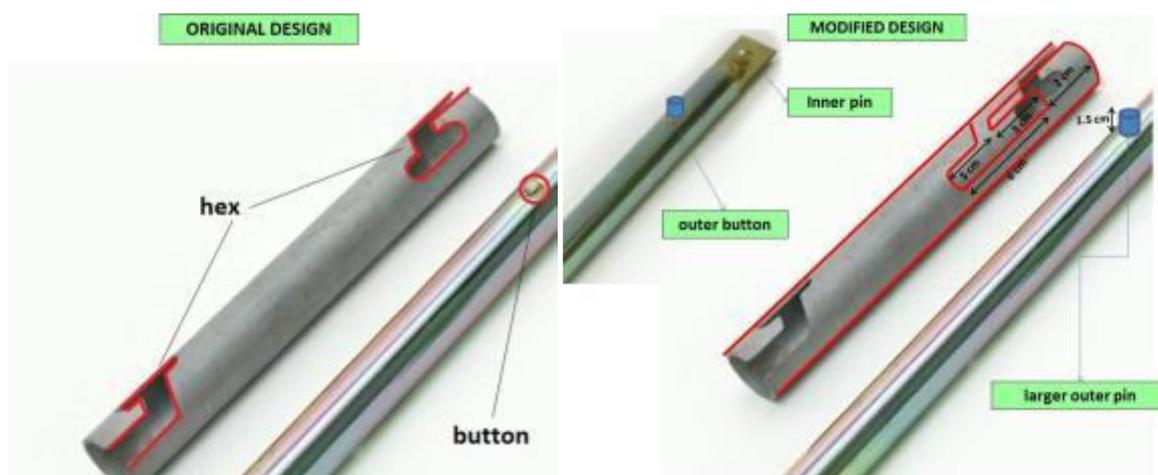
Figure 39 (LEFT) Original design (RIGHT) Modified design of connector used in the study after several auger heads were lost at the beginning of the survey.

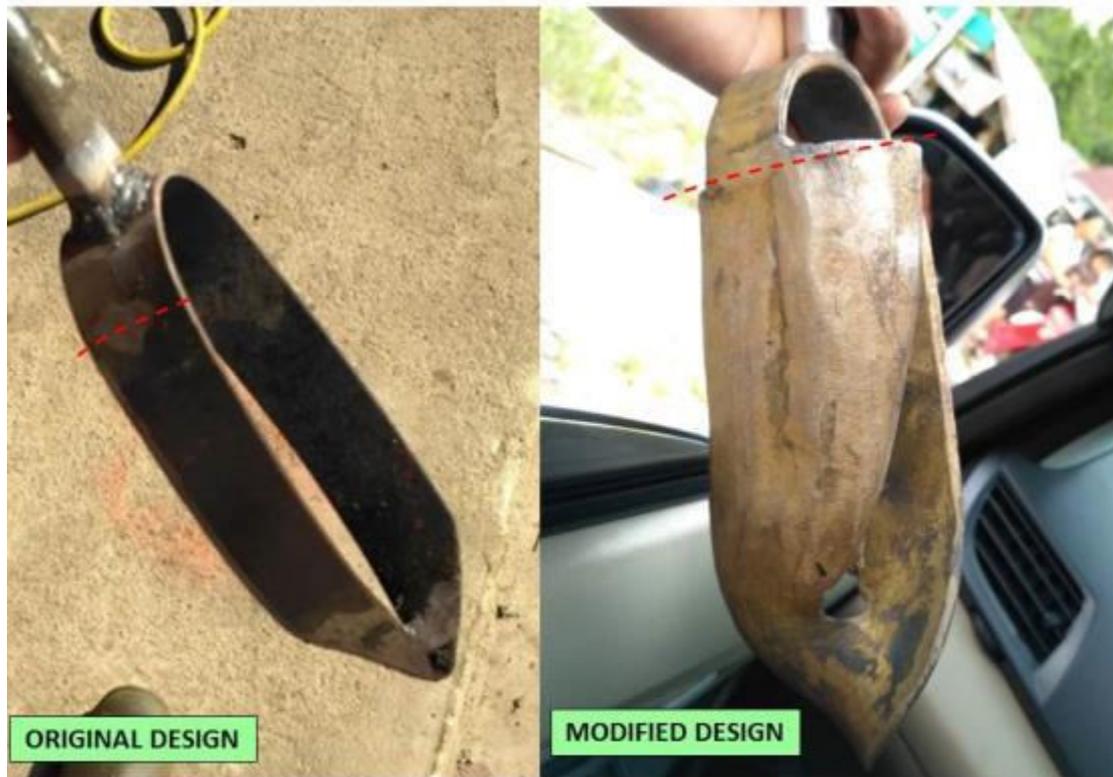
Figure 40 (LEFT) Original Edelman type auger head used at the start of the survey and (RIGHT) Modified Edelman auger head from week 2 of the survey onwards.

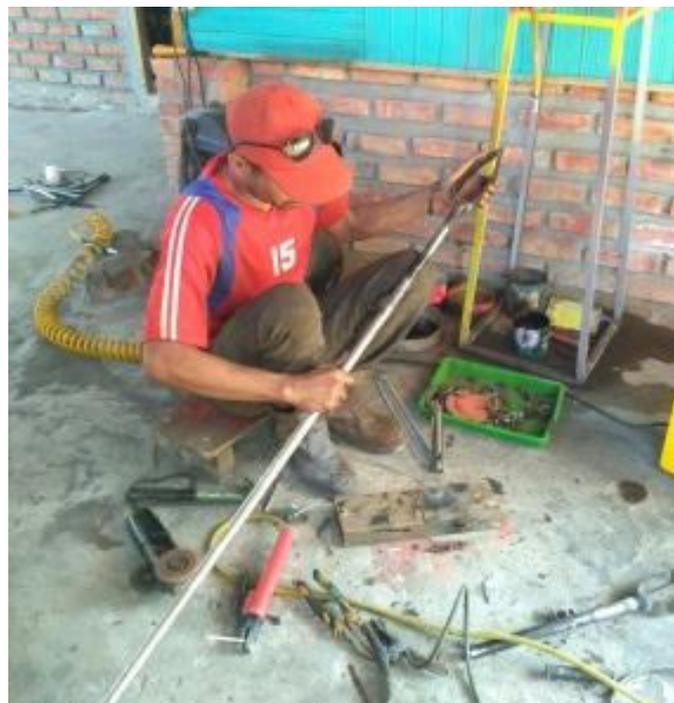
Figure 41 Duplicating auger head in the local workshop.

During the first week of the survey, three auger heads were lost. The auger heads were trapped in the deep peat and could not be retrieved since the connector failed to secure the connection with the extension rods during retrieval. One more auger was lost in the second week. Following the loss of these auger heads, the auger connections were modified so auger heads have a bigger bolt and extension rods are connected using a longer hex connection (see Figure 39). In addition, in order to trap more soil, the team also decided to modify the auger head as shown in Figure 40. The modifications to the auger were carried out at a local workshop in Desa Pematang Duku (Figure 41).

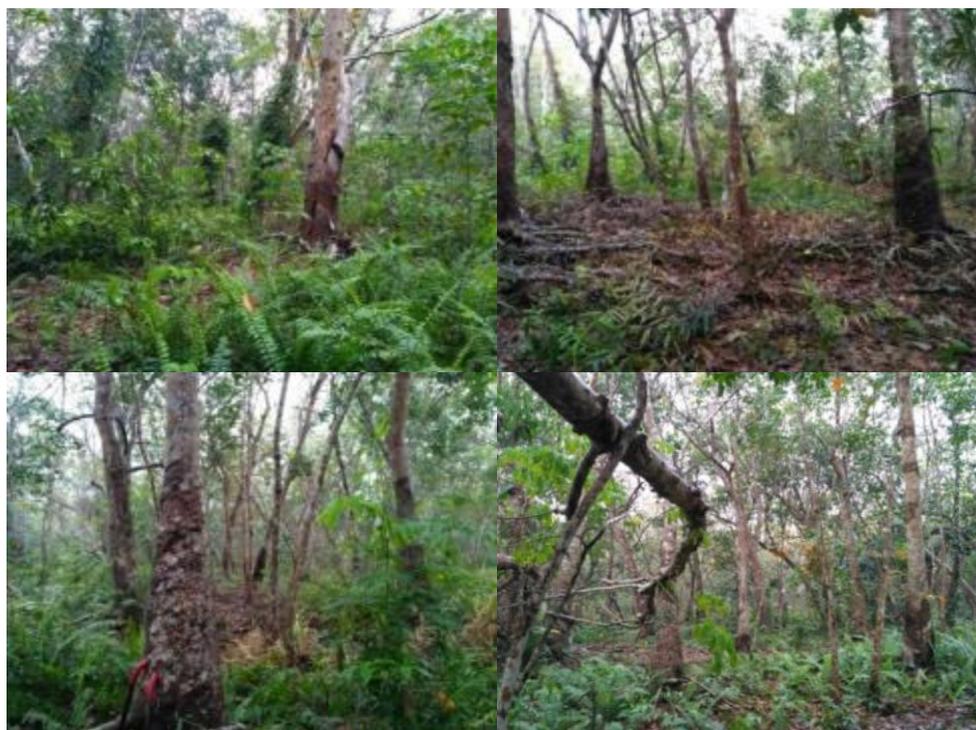
Figure 42 Vegetation cover as observed in four directions at sampling location GPS-160. (LEFT) North, (RIGHT TOP) East, (LEFT BOTTOM) South and (BOTTOM RIGHT) West.

Vegetation cover and land use was documented at each survey location and photographed in four directions (Figure 42). The augering process in the field is shown in Figure 43. Mineral subsoil that was trapped in the auger was photographed as evidence that the peat bottom had been reached (Figure 44).

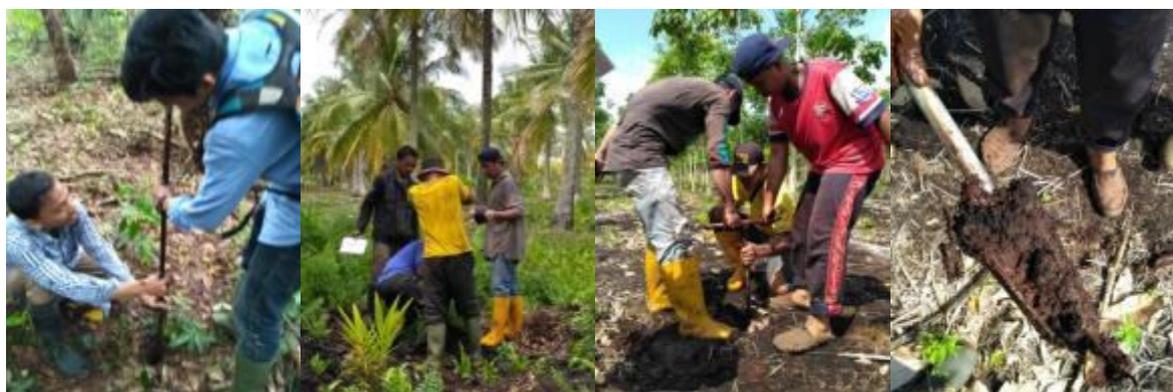
Figure 43 Augering process at the sample location.

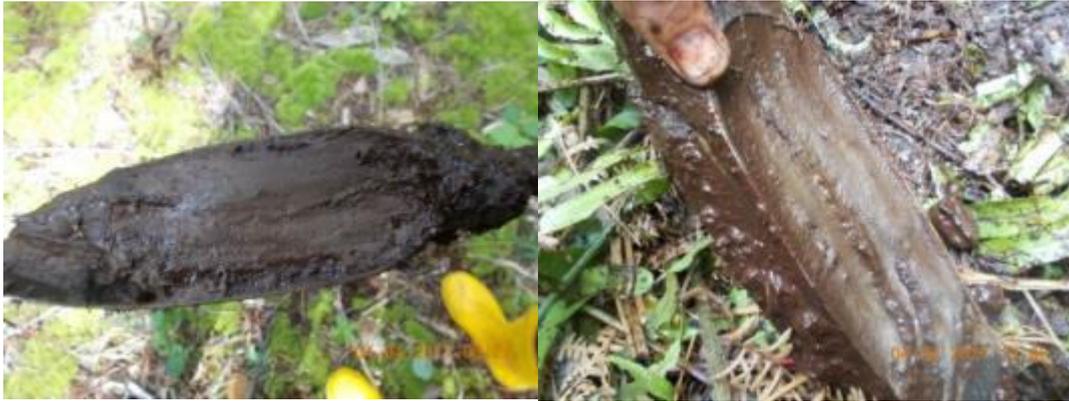
Figure 44 Mineral soil found below the peat at (LEFT) GPS-43 and (RIGHT) point GPS-40.

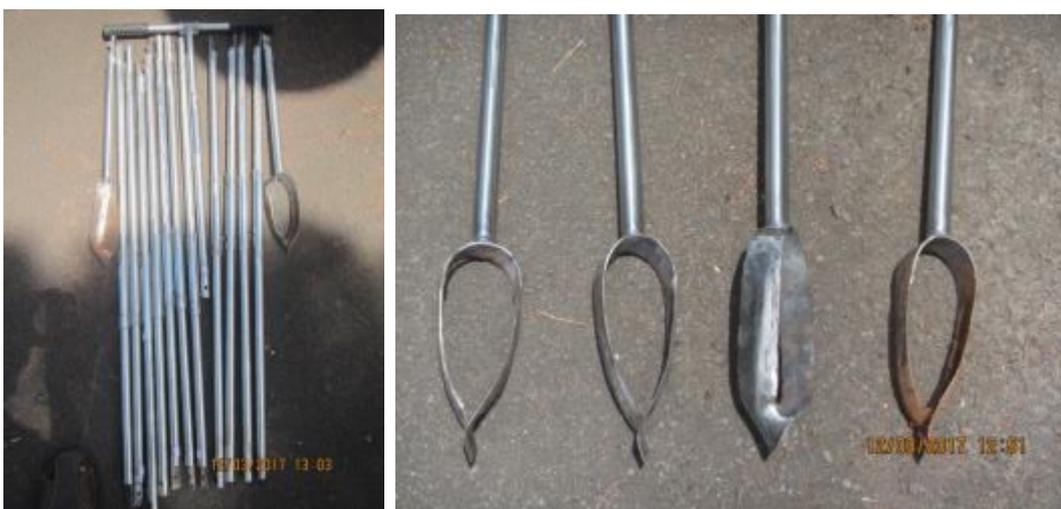
Figure A.1 Edelman Auger set

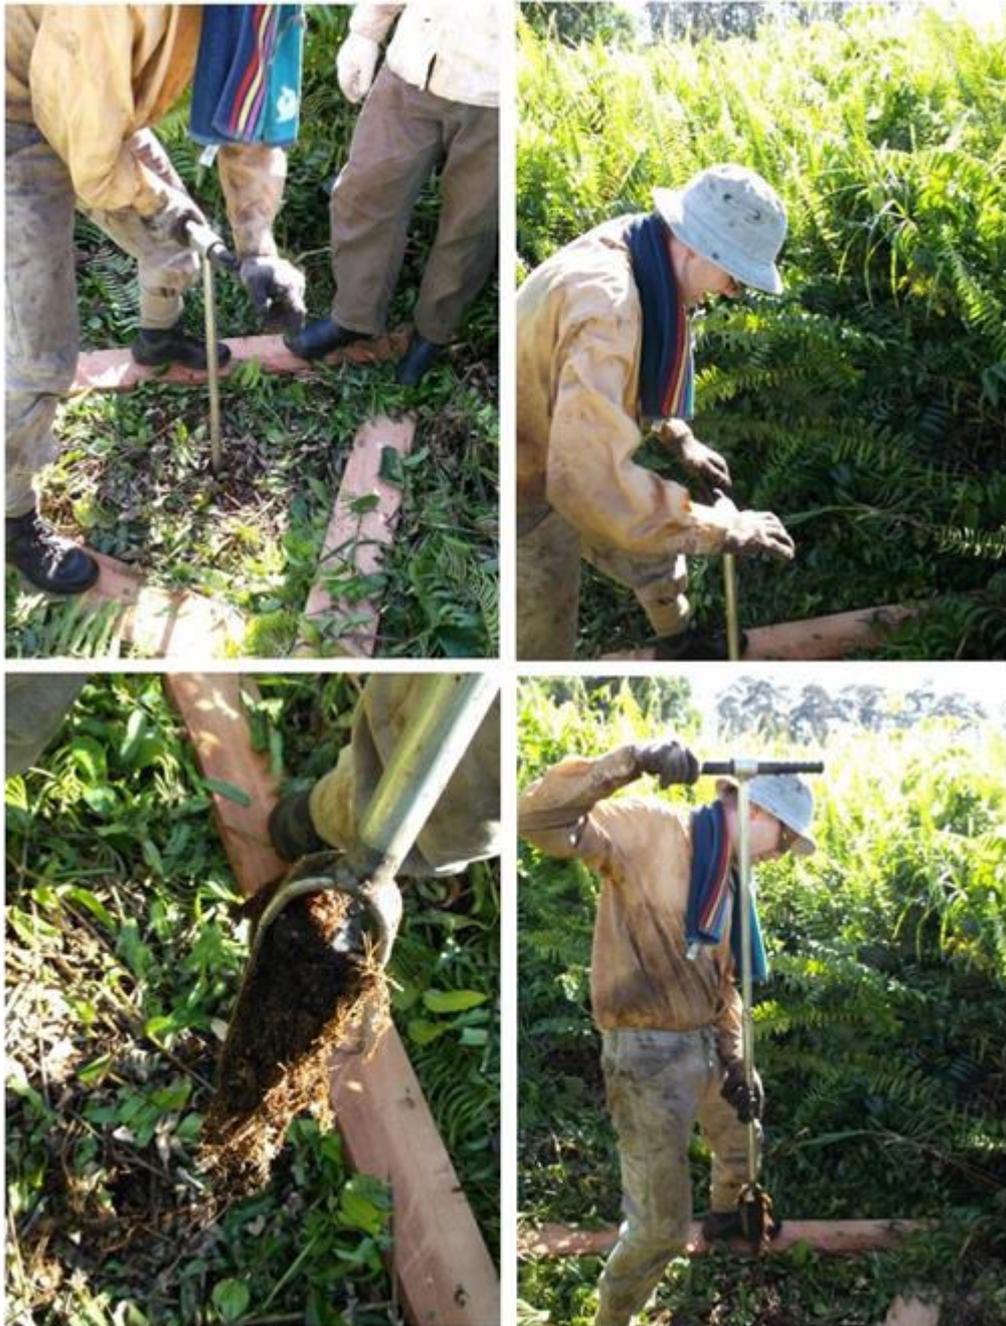
Figure A.2 The initial stage of peat drilling

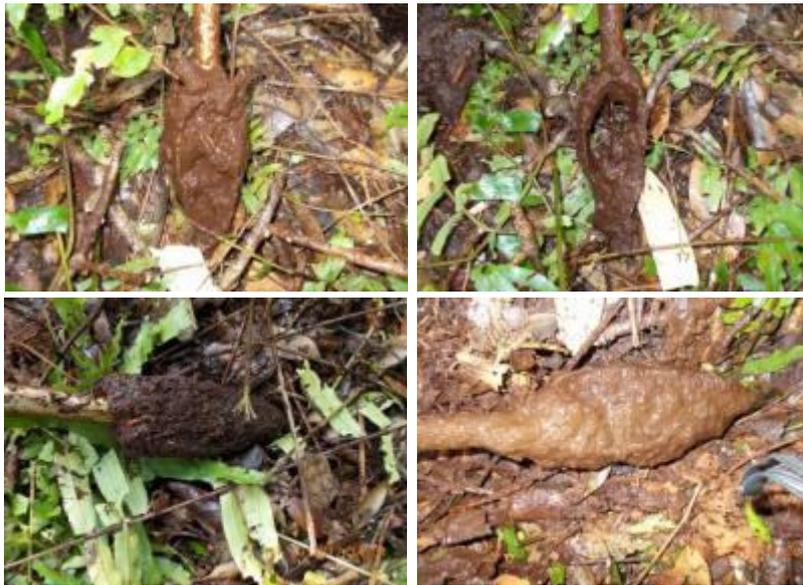
Figure A.3 Example of soil trap in the auger body

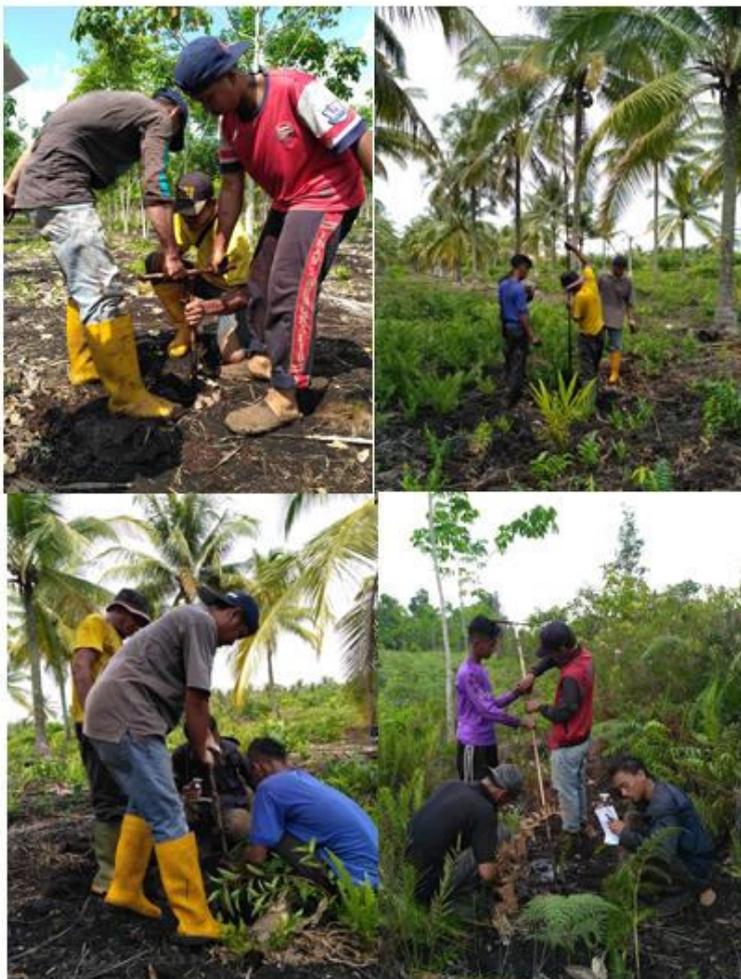
Figure A.4 The process of removing and connecting the extension rods and continue drilling

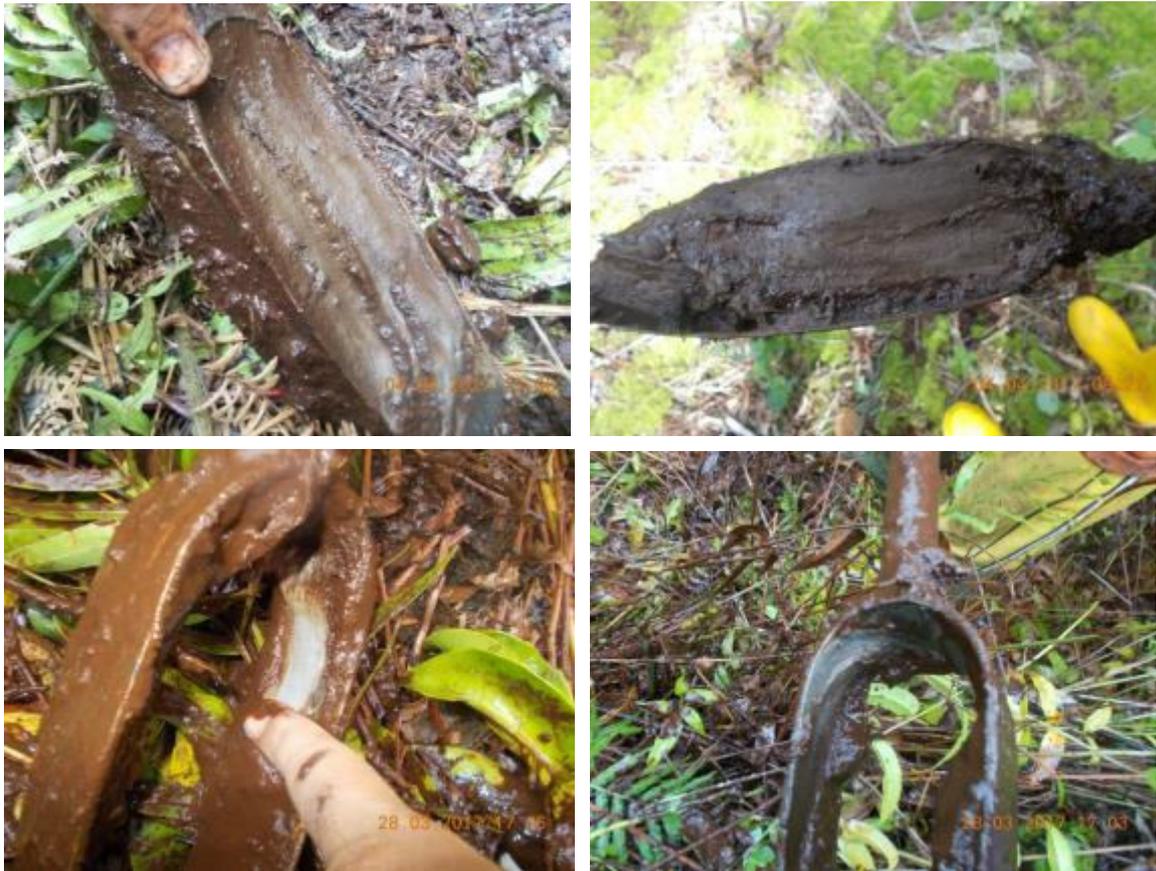
Figure A.5 The example of auger that has reached the mineral soil (clay).
